# Risks associated with nearshore instability Inskip Point, Qld

Prepared for:  
Queensland Parks and Wildlife Service

Document Reference:  
B01006-IAE

Version:  
25 November 2015

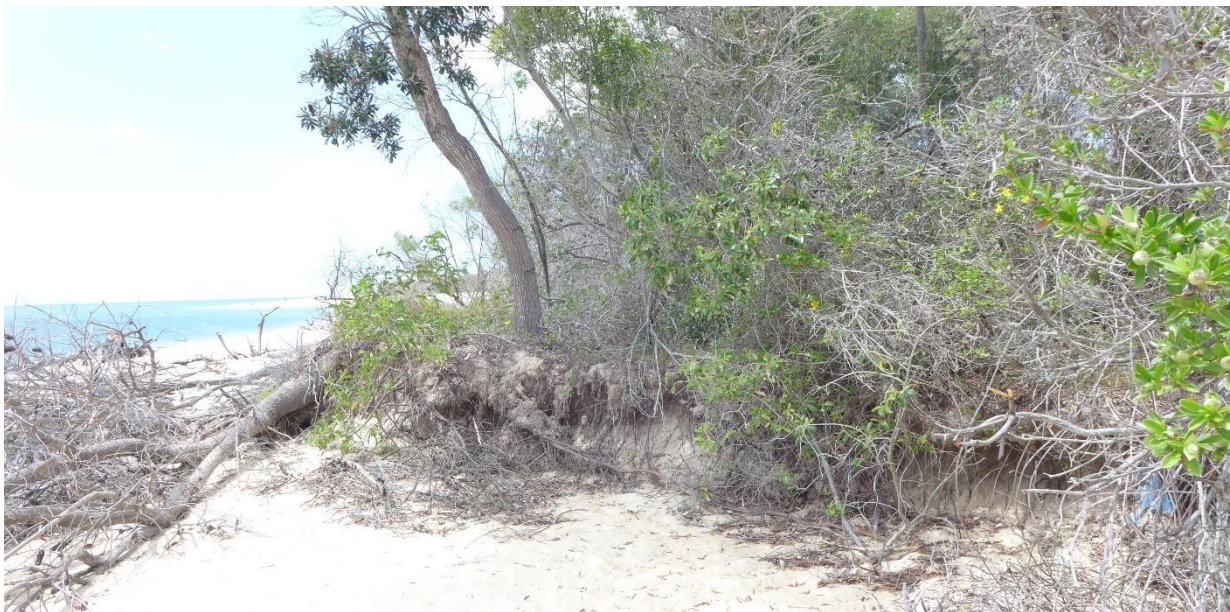
Within some of the broader scallops in the vegetation at the back of the beach, scarps are evident within the sand up to about 0.7m high, coinciding with zones of fallen trees (Figure 2.1). As these scarps are evident at elevations above the usual high water level of about 2m, we interpret them as the back scarps of previous instability events rather than the consequence of storm surge, as they are arc shaped and do not extend over the entire back beach area. In subsequent sections we present correlation with observed scarps and the locations of past instability events.

Figure 2.1 A small scarp at the rear of the vegetation line which is interpreted as the rear ward extent of past instability

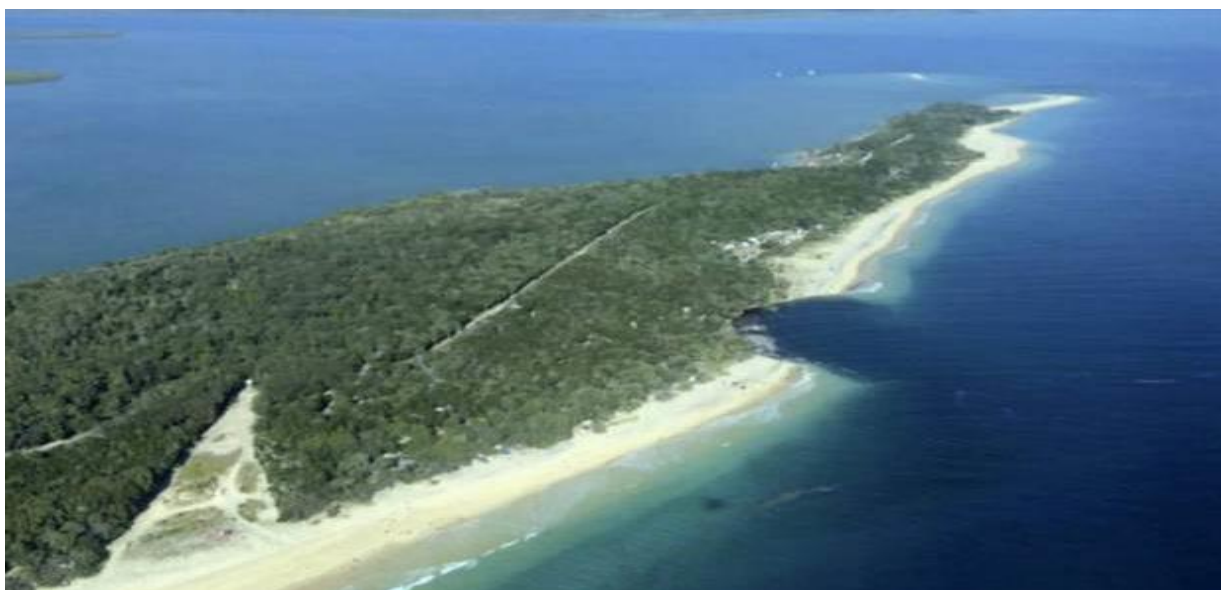
Figure 2.2 is a publically available aerial photograph which shows the general shape of the September 2015 instability event. We made the following observations on our site visit of 27 September 2015, about 18 hours after the initiation of instability:

- The affected zone was in the form of an arc up to about 200 m wide.
- There was a sub vertical scarp at the back of the arc varying in height from 0.5 m to 1.5 m.
- Parts of the back scarp were being stabilised (i.e. held near vertical) by the roots of trees (Figure 2.3).
- A shallowly sloping (less than 10°) beach of about 5 m width had started to form below the back scarp.

- Out beyond the newly forming beach the sand dropped away at a much steeper angle, with dark blue water within the zone of instability suggesting a depth of 5 m or more quite close to the edge of the beach.
- Several trees up to about 8 m high had fallen into the zone of instability as their roots were undercut by the encroaching event.
- At this time the back scarp of the zone of instability did not appear to be retrogressing significantly.

Figure 2.2 Oblique aerial image of the 26 September 2015 instability event. Image source: ABC.Net.Au

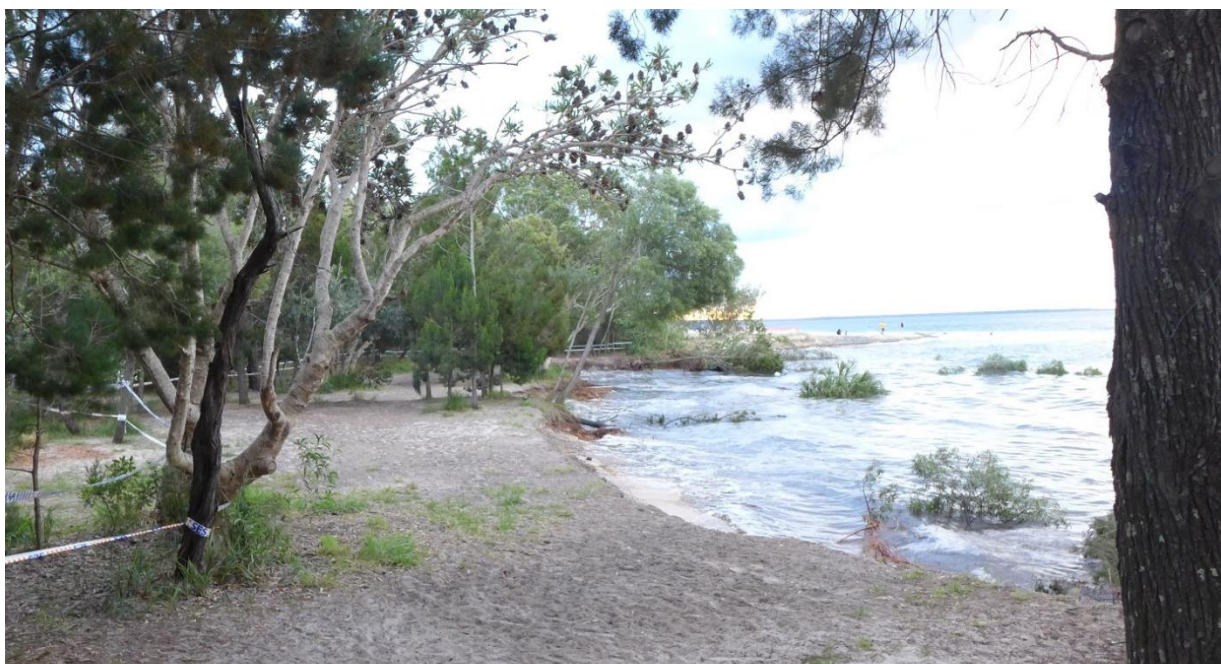
- The back scarp of the zone of instability had regressed only 2 m to 3 m metres from the position observed on Saturday evening and been reduced in slope in some parts to form a beach.
- Rapid and turbulent tidal flows and eddies were evident along the edge of the channel, where the adjacent beach falls to the sea floor.

Figure 2.3 View across the rear of the instability event looking west on the afternoon of 27 September 2013

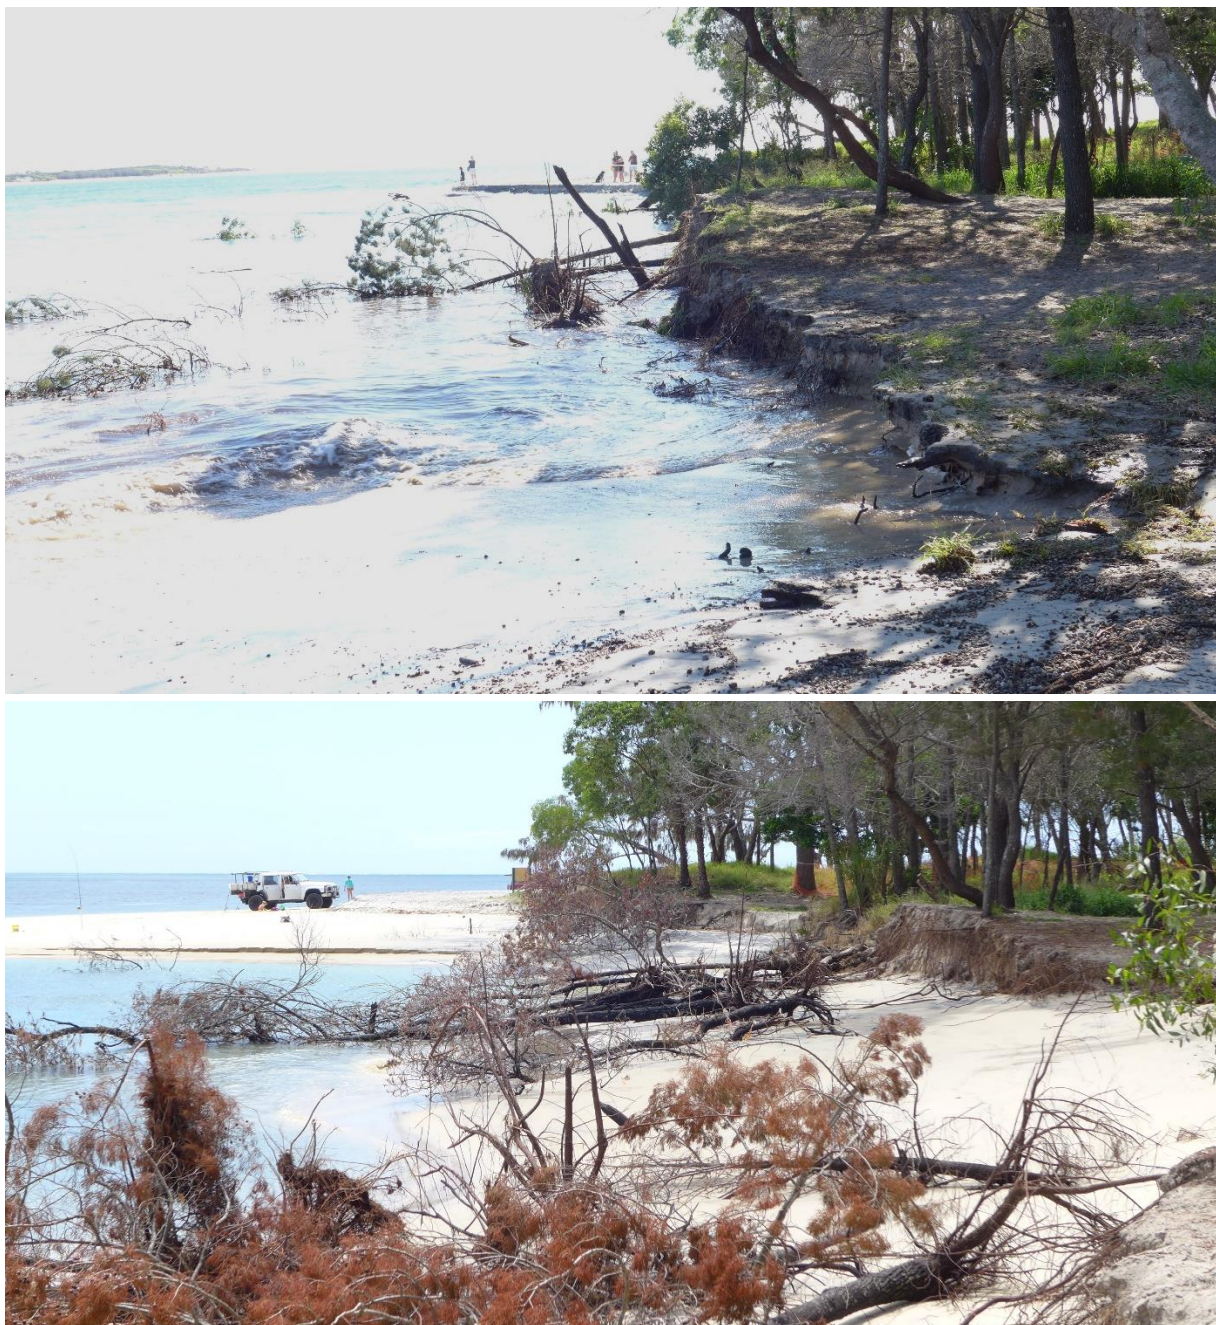
In our follow up visit on 26 October 2015 to assess surface conditions along the whole peninsula we observed regression of the back scarp of about 3 m and some broadening of the beach below the scarp as shown on Figure 2.4.

Figure 2.4 Similar view from 26 September 2015 at around high tide (top) and 26 October 2015 at about low tide (bottom) illustrating several metres of further regression of the back scarp.

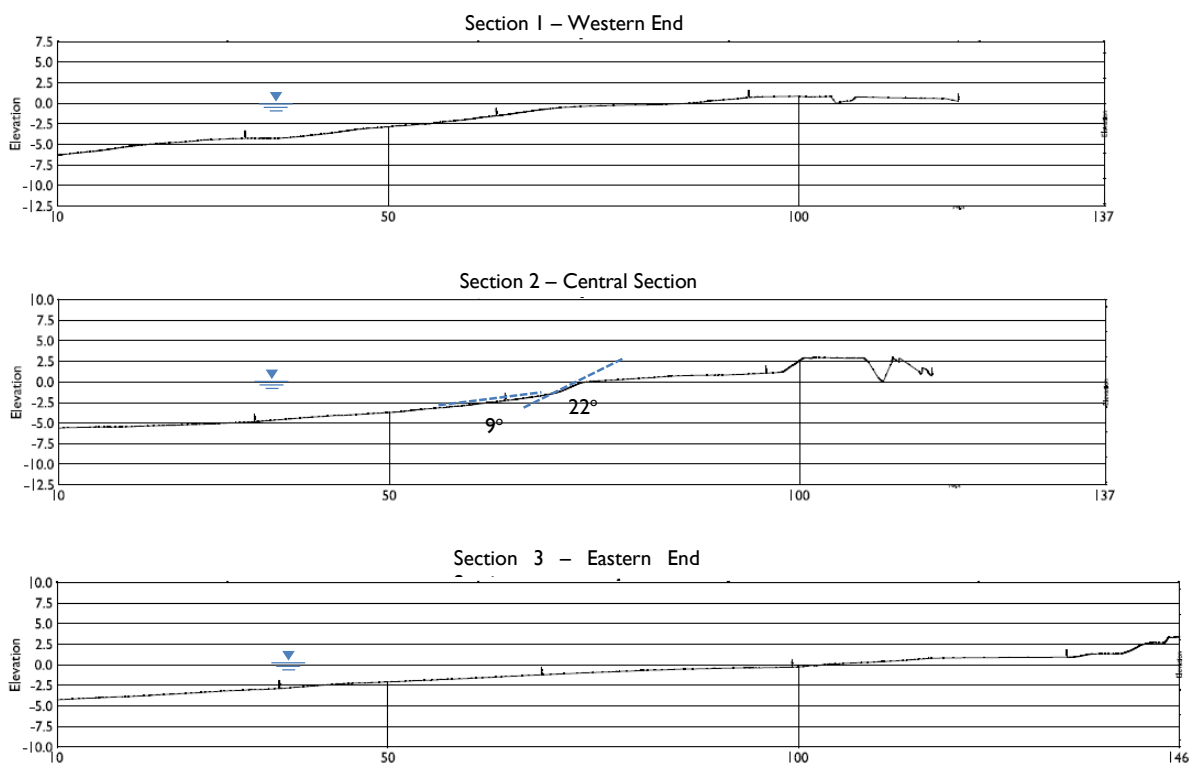
Figure 2.5 Cross Sections through three sections of the beach and near-shore zone. Section 1 represents the western most zone near the tip of the peninsula; Section 2, the main east-west extent of the beach; and Section 3 eastern end where the beach is oriented more towards the north-west.

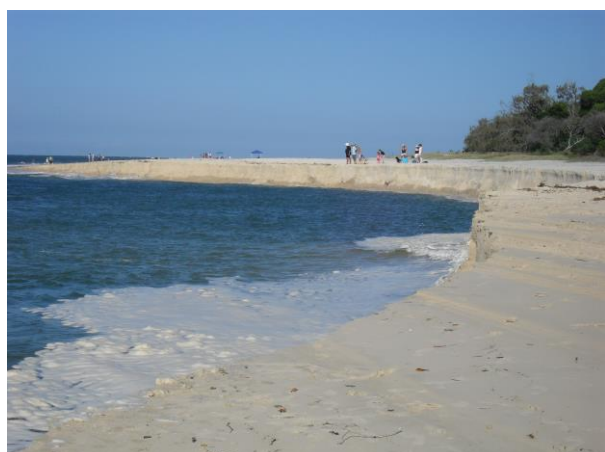
a. 2010-1

Figure 3.1 Photographs showing the head scarp of four separate instability events at Inskip Point either within the early stages of retrogression (a,b) or a within day following (c,d)

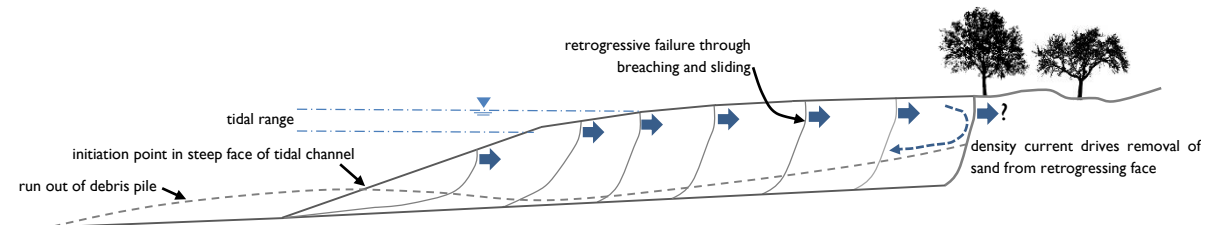
Figure 4.1 Diagrammatic cross section through breach flow slides at Inskip Point. Not to scale and with minor vertical exaggeration to demonstrate mechanisms.

- As the pore pressure progressively equalises at the face, sand is released grain by grain and falls from the wall.
- As the grains fall they develop a density current (a “fluid” with a higher density than seawater due to the presence of the sand grains, which flows downwards) which carry grains away from the face and beyond the immediate toe of the failure surface, allowing the face to remain steep.

- Where very steep slopes are developed by the process, a secondary mechanism involves sliding of blocks of sand from the scarp which has been observed in many instances of instability at Inskip Point.

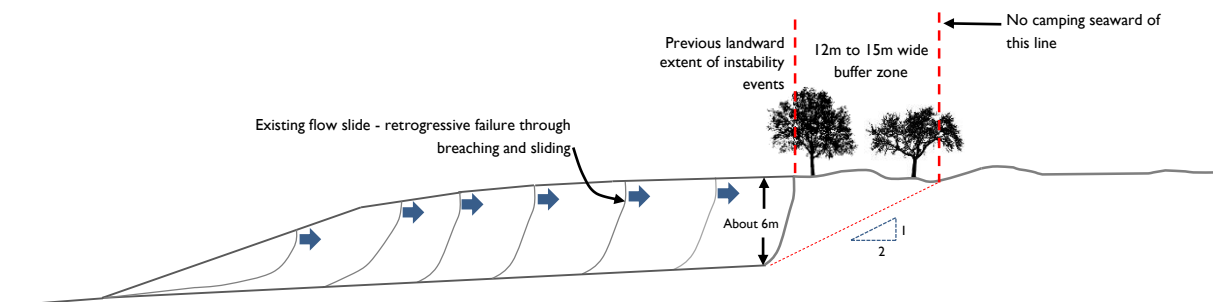
Figure 6.1 Diagrammatic cross section showing the geotechnical derivation of the buffer zone based on previous encroachment of the flow slides.

To assist in the assessment of whether a restriction on camping for some parts of the peninsula would be practical, we have prepared a preliminary boundary to the buffer zone based on the location of past instability events with a safety margin to take into account the required offset from a potential scarp. Figure 6.1 shows the geotechnical basis for establishing the buffer zone. There are practical requirements such as the positioning of roads and other infrastructure which will also govern the precise location of the buffer zone. We worked with staff from QPWS on site to establish the practical position of the proposed buffer zone taking into account both geotechnical and practical considerations. Drawing 5 shows the proposed buffer zone boundary beyond which camping would need to be restricted in order to reduce risk to campers.
