## Fort Bribie – defending Brisbane in WW11

Fort Bribie was built to defend the North West Channel into Moreton Bay during WW II. Now its remains are under attack from a different challenge: the persistent forces of coastal erosion.

Queensland National Park rangers are working to preserve Fort Bribie digitally through imagery, GIS mapping and 3D rendered modelling. We invite you to explore the fort when it was operational, view the changes over time, and appreciate the coastal processes that will eventually bring its demise.

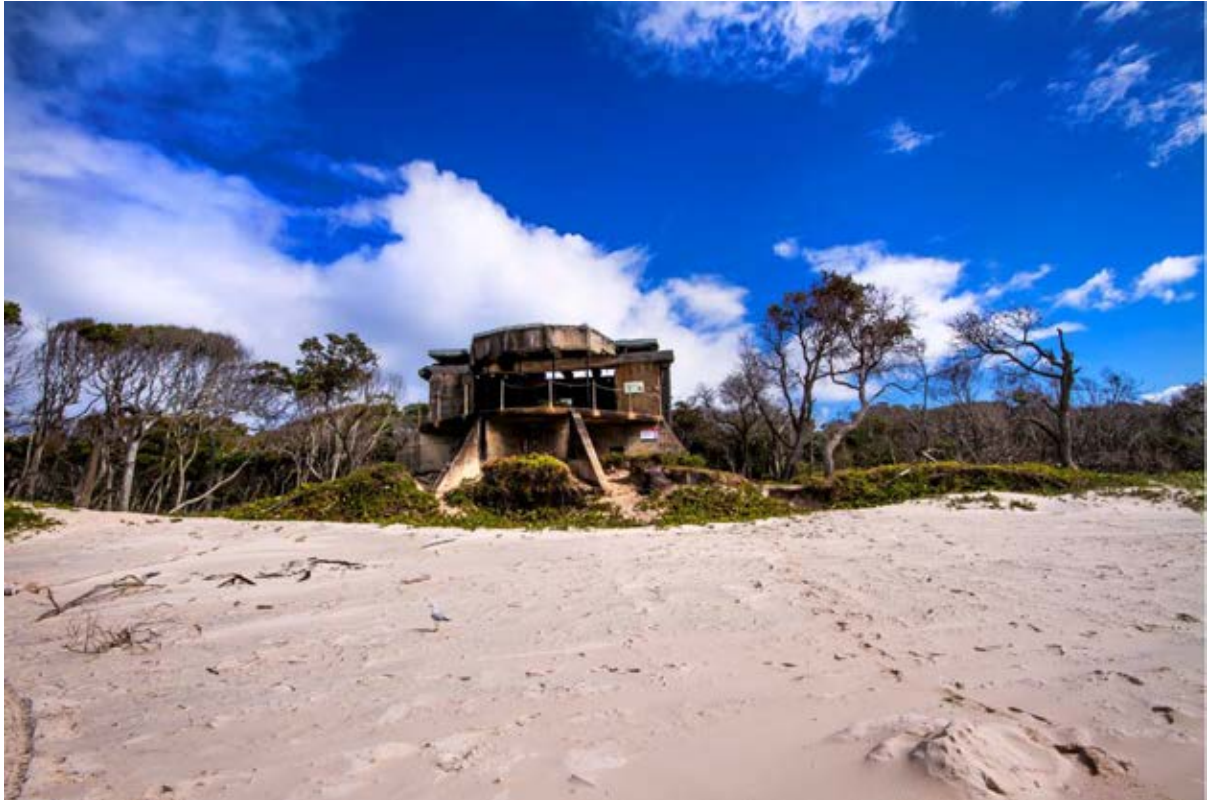
**Number One gun emplacement** (southern gun). Photo Matt Nash-Arnold © Qld Govt

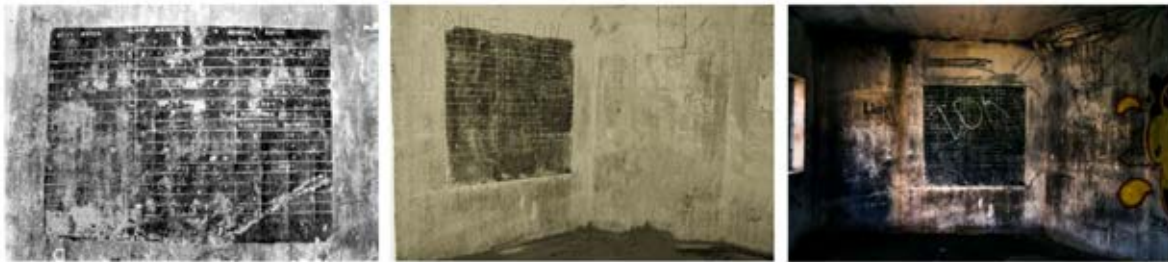
**Roster board inside the southern gun emplacement** — 1980, left (© Sunshine Coast Libraries), 2006, centre (Marcus Toyne © Qld Govt) and 2018, right (Matthew Nash-Arnold © Qld Govt)

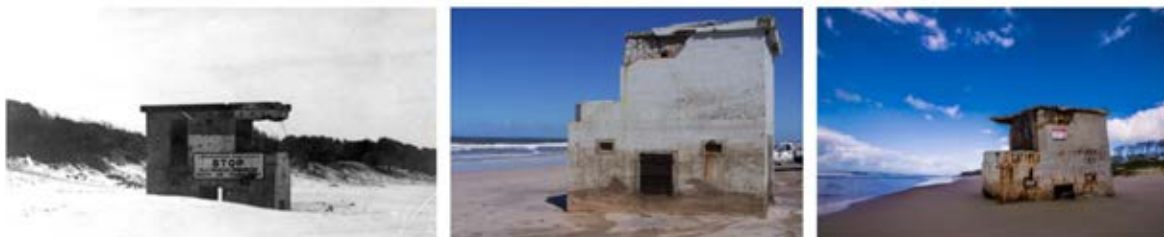
**Northern observation post** — 1980, left (© Sunshine Coast Libraries), 2006 centre (Marcus Toyne © Qld Govt) and 2018, right (Matthew Nash-Arnold © Qld Govt)

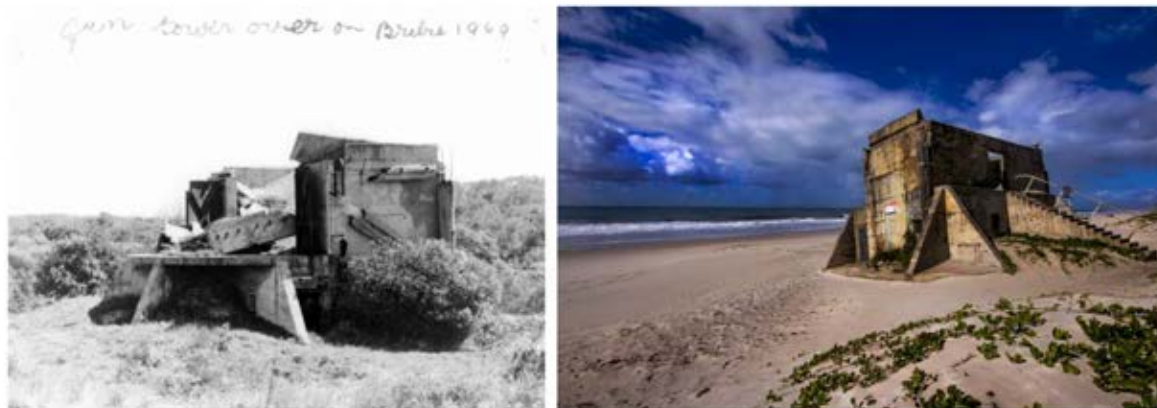
**Northern gun emplacement** — 1969, left, (© Sunshine Coast Libraries) and 2018, right, (Matthew Nash-Arnold © Qld Govt). The photographs demonstrate the significant beach erosion impacting the structure.

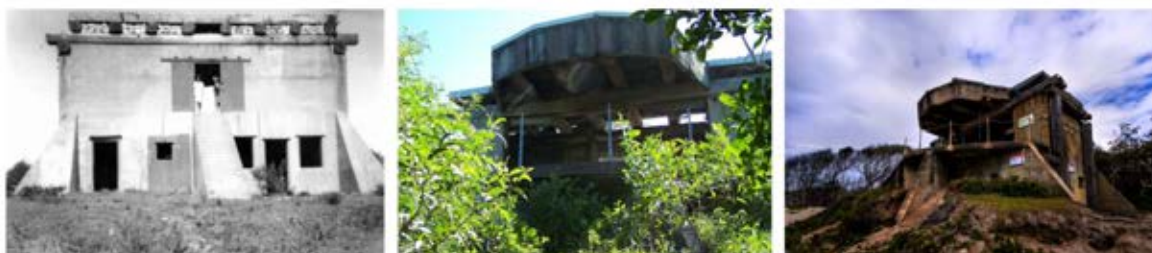
**Number One gun emplacement (southern gun)** — 1946, left, (© Sunshine Coast Libraries), 2006, centre (Marcus Toyne © Qld Govt) and 2018, right (Matthew Nash-Arnold © Qld Govt)

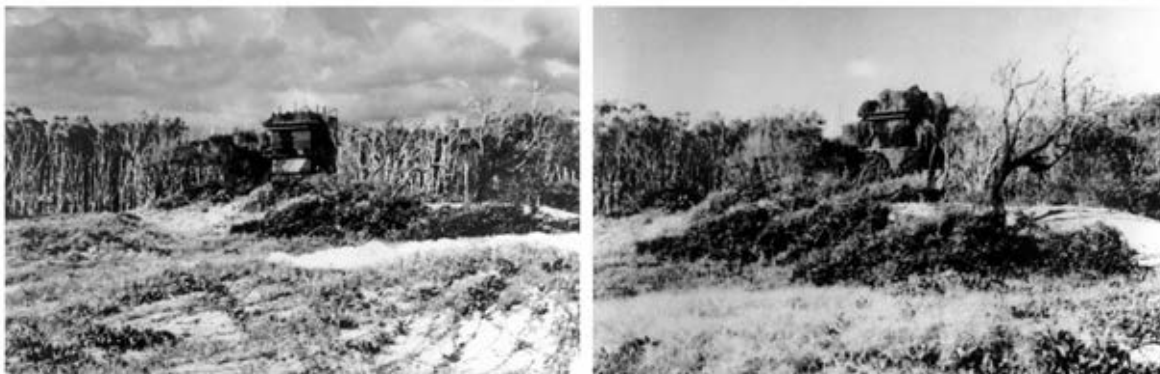
Fort Bribie's Command Post, 1942. (© Sunshine Coast Libraries)

In the area to the west and south of the SOR are a number of concrete slabs and concrete stumps for various camp buildings. Other concrete structures survive around the camp area, including several round wells, urinals, pump house, septic tank, and septic pipeline mountings. Little remains of the Command Post (CP) at the south end of the men's section of the camp.

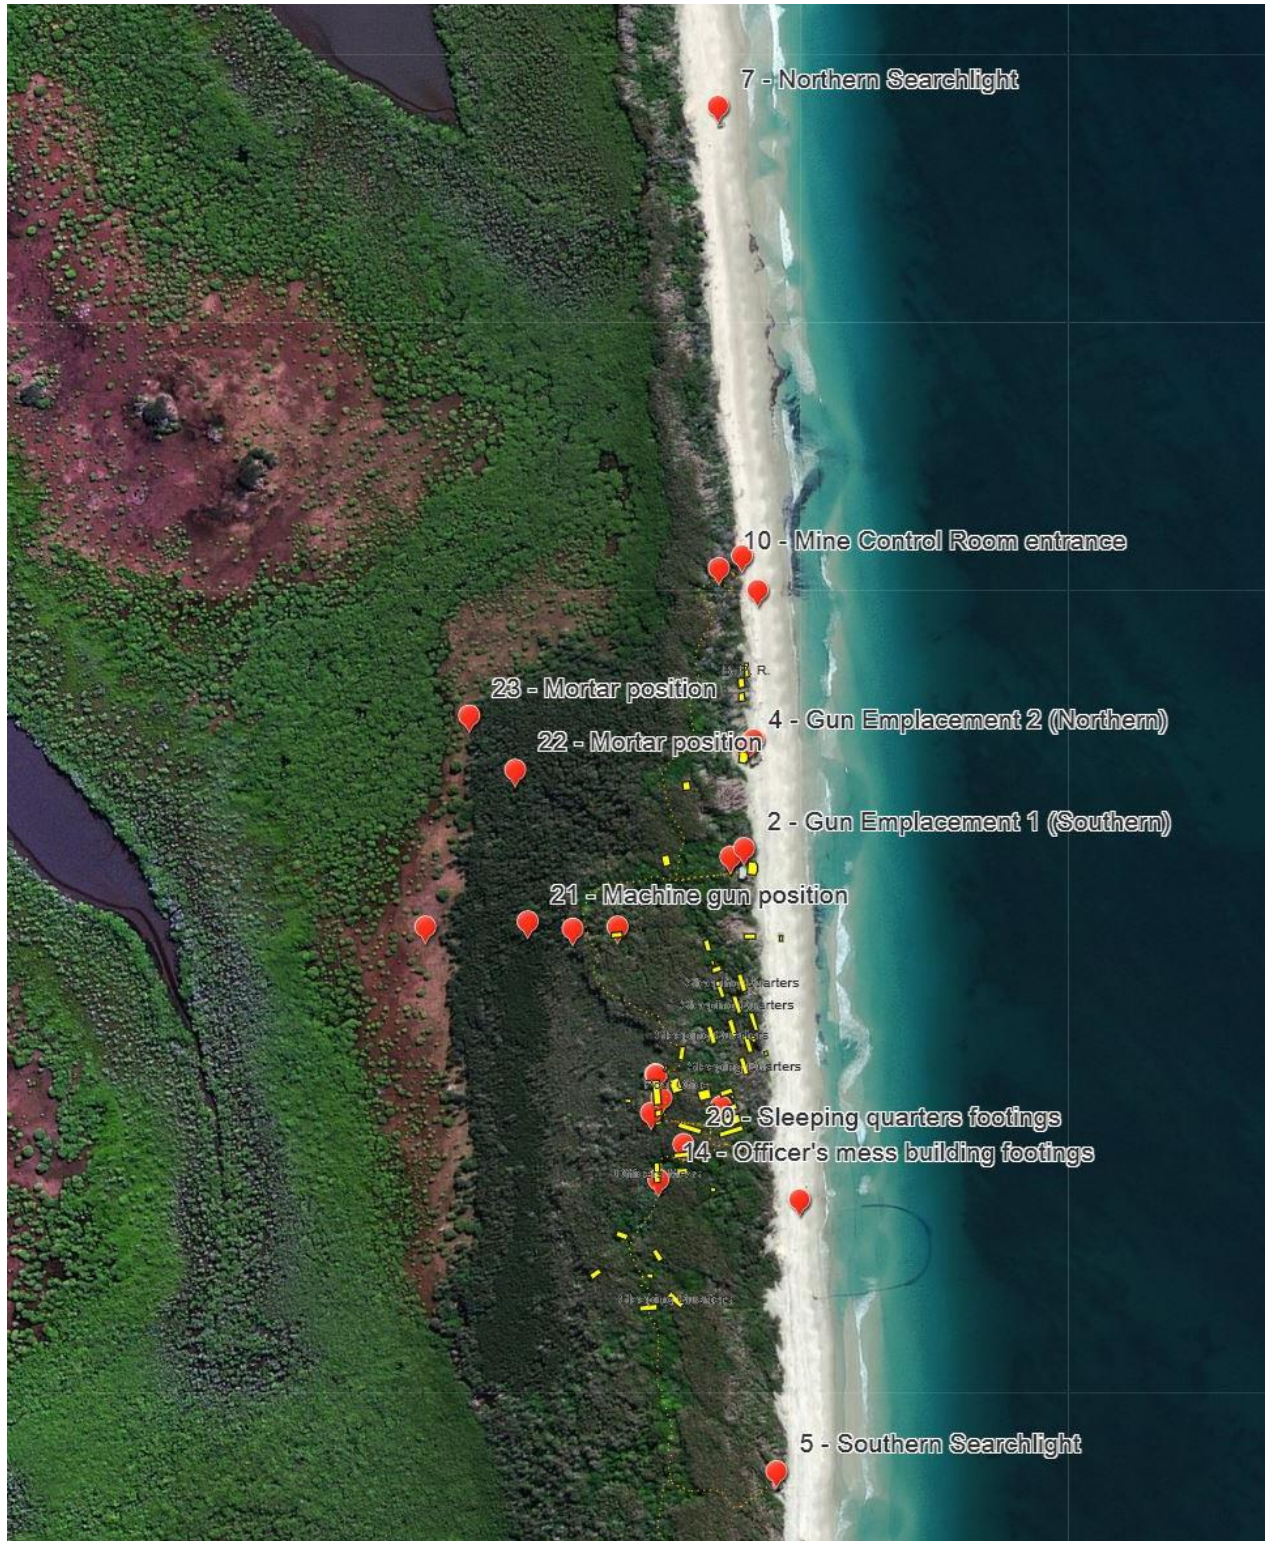
The red teardrops show where the photographs in this section were taken.

Map of the location of the Fort Bribie infrastructure photos

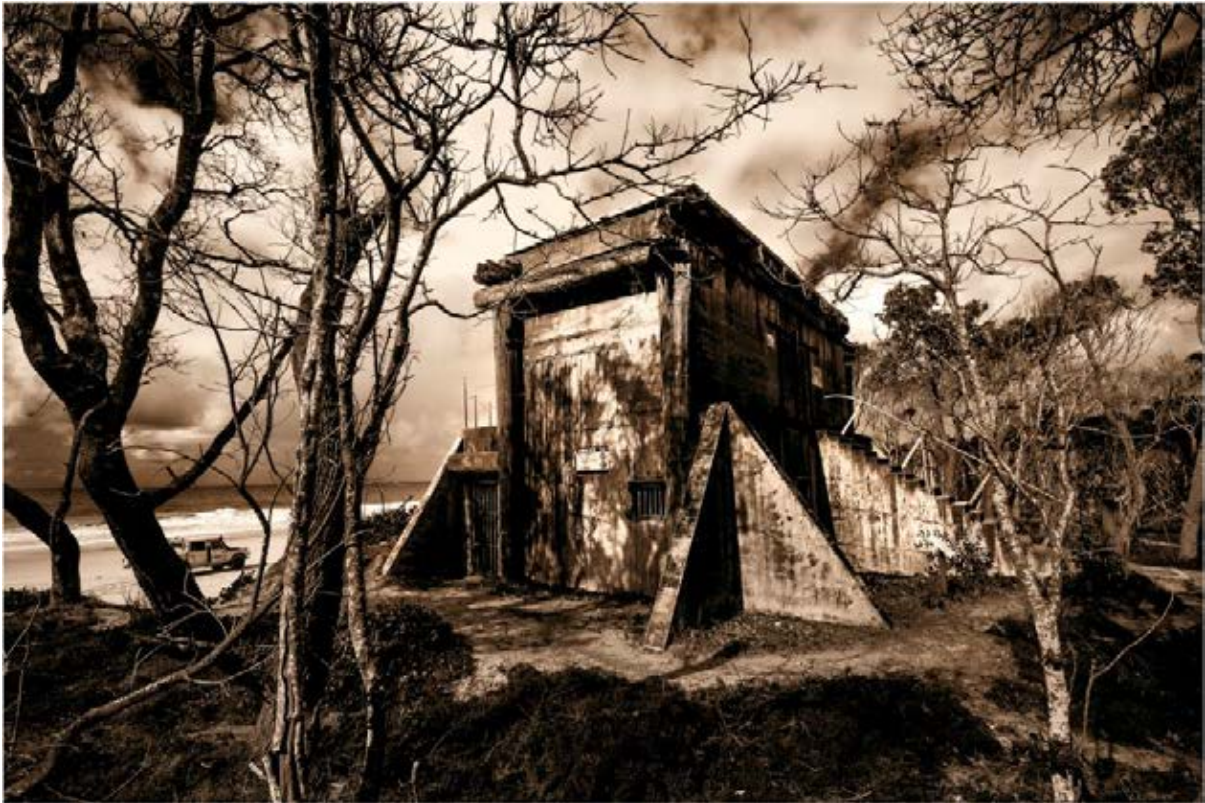
Photo 1: Gun Emplacement 1 (Southern) side view

**Gun Emplacement 1 (southern).** Photo June 2018, Matthew Nash-Arnold © Qld Govt

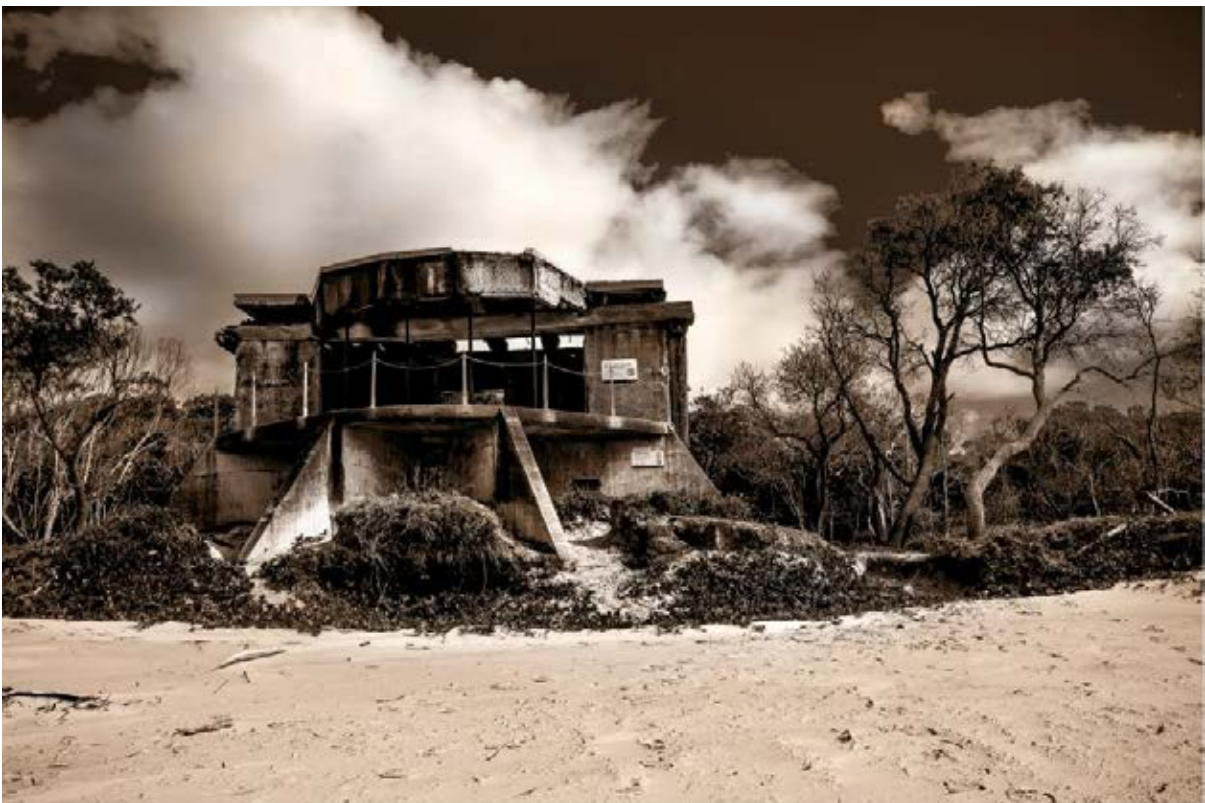
Photo 2: Gun Emplacement 1 (Southern) beach view

**Gun Emplacement 1 as viewed from the beach.** Photo June 2018, Matthew Nash-Arnold © Qld Govt

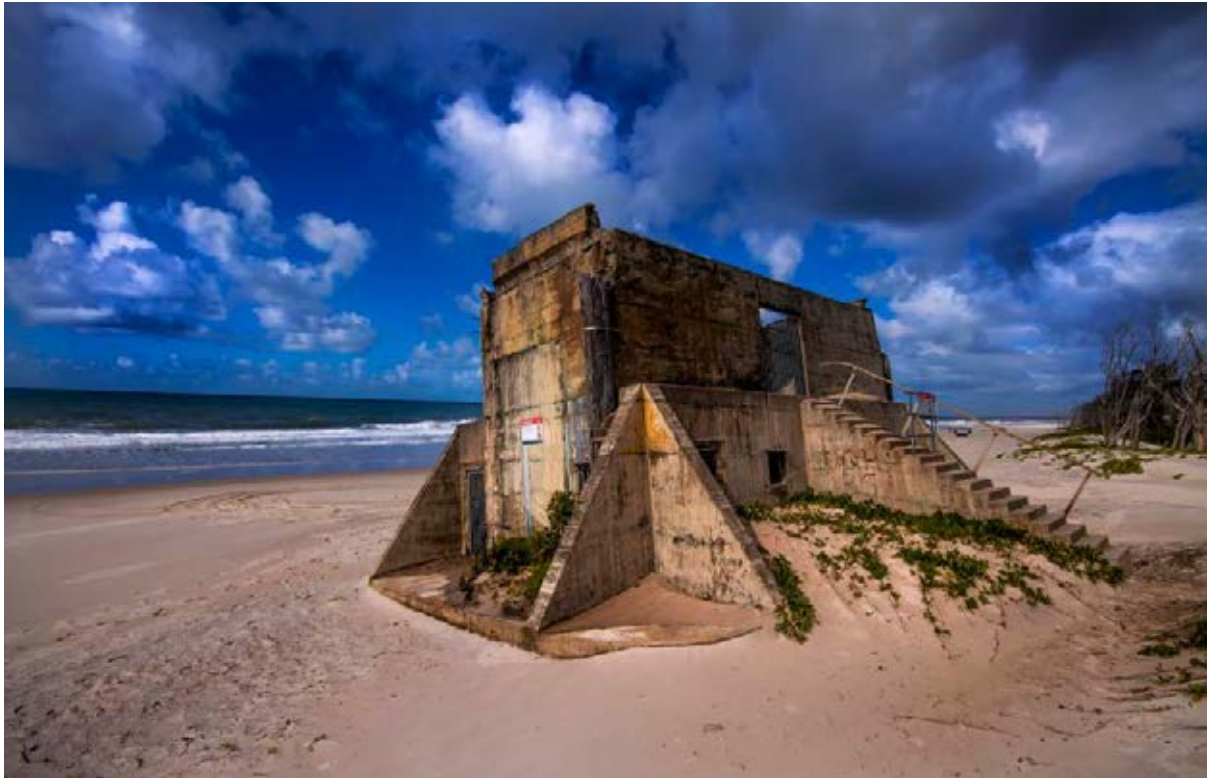
### Photo 3: Gun Emplacement 2 (northern) looking south

Significant erosion to the beach over the decades has exposed several fort structures. This photo shows the gun emplacement structure now well below the dune line on the beach in June 2018.

Gun Emplacement 2 (northern) looking south to Woorim. Photo June 2018, Matthew Nash-Arnold © Qld Govt.

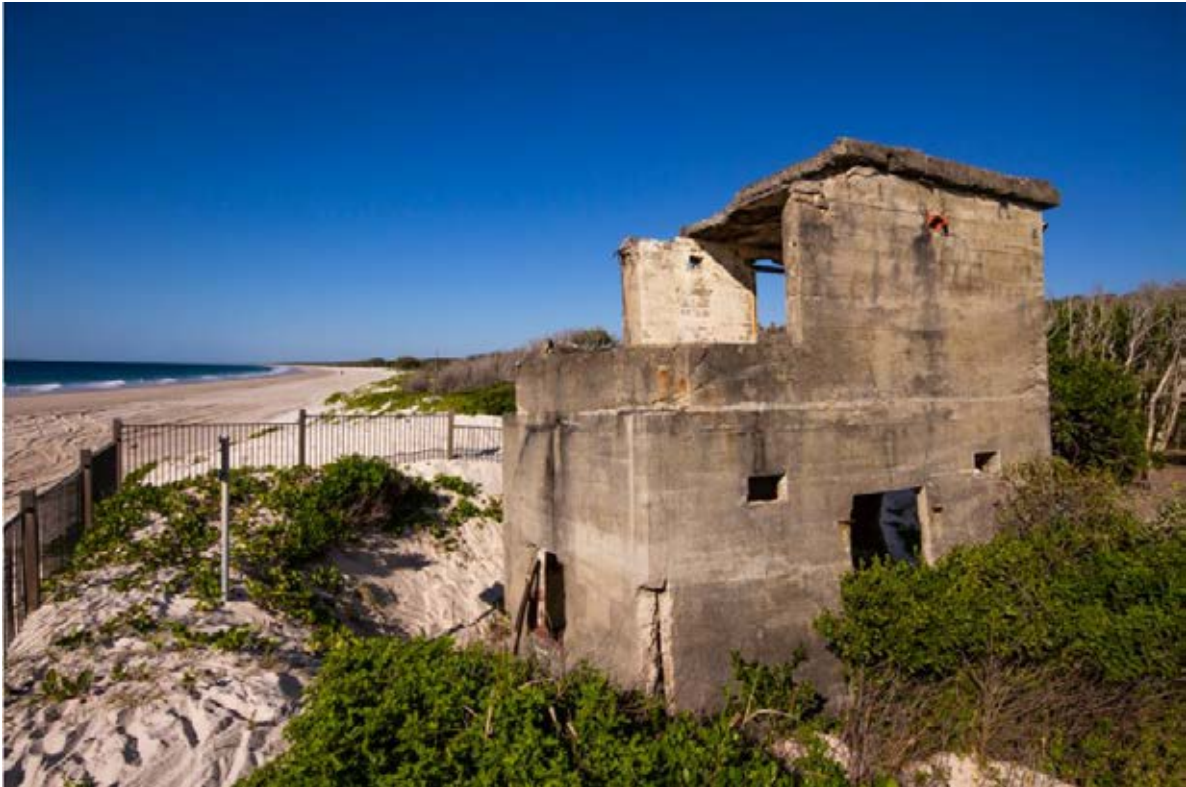
### Photo 5: Southern Searchlight

Photograph looking south to Woorim showing the southern searchlight structure. There are two searchlight buildings located approximately 1.2 kilometres apart.

**Southern searchlight.** Photo July 2018, Matthew Nash-Arnold © Qld Govt.

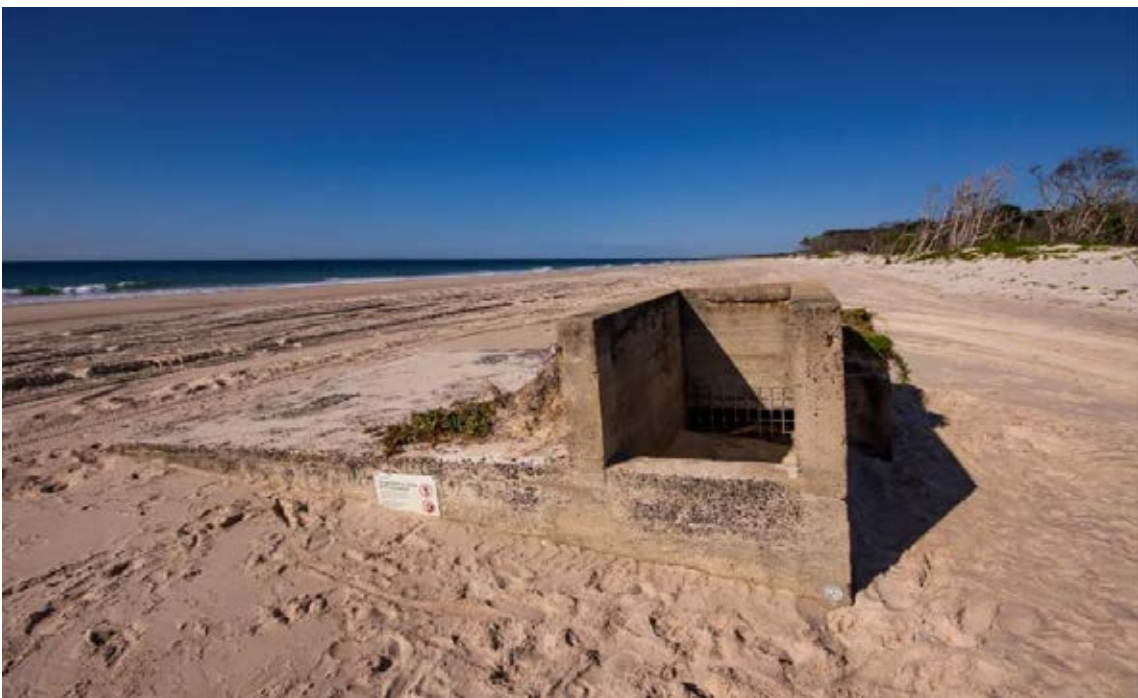
### Photo 6: AWAS Signal Station

Australian Women's Army Service (AWAS) Signal Station, looking south to Woorim. The Signal Station was used to manage all phone calls in and out of Fort Bribie. This building used to be located well behind the dune line but is now on the beach.

**Australian Women's Army Service (AWAS) Signal Station.** Photo July 2018, Matthew Nash-Arnold © Qld Govt.

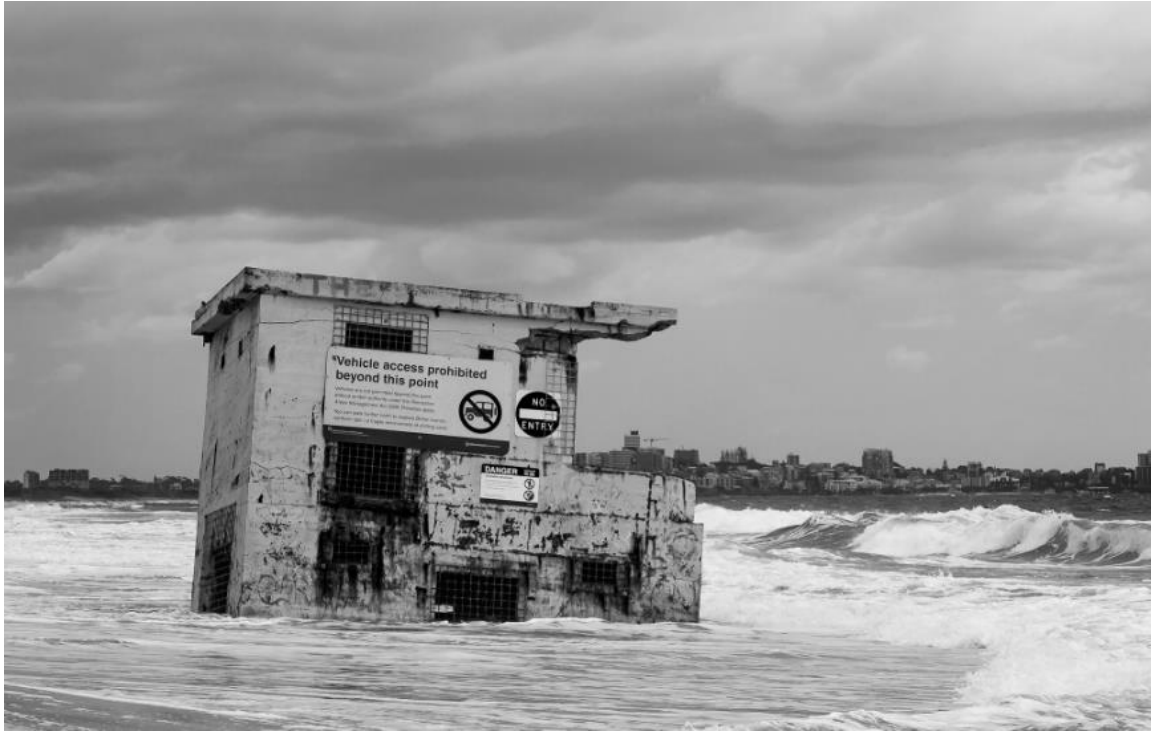
### Photo 7: Northern Searchlight

The northern searchlight structure looking north to Caloundra. This building used to be located behind the second row of dunes. The two searchlight buildings were used to illuminate targets for the fort's guns.

**Northern Searchlight.** Photo November 2018, Matthew Nash-Arnold © Qld Govt.

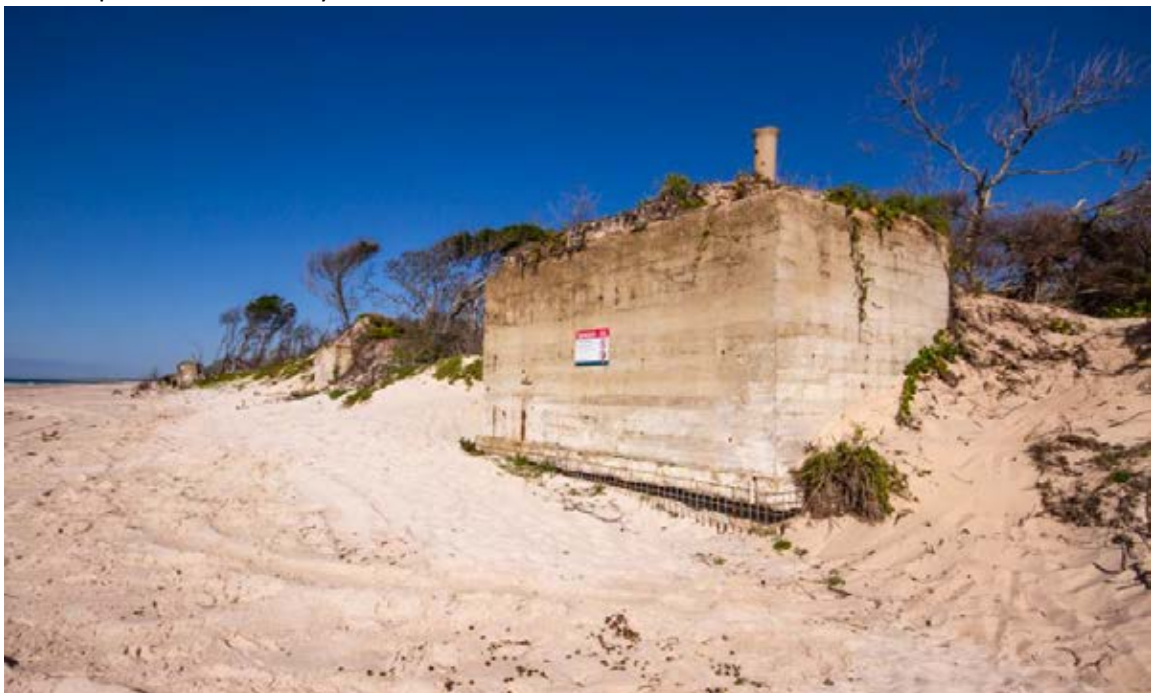
### Photo 8: Mine Control room.

The Mine Control Room (MCR) was used to monitor and coordinate several 'mine loops' which ran out perpendicular to the beach. These structures were located well behind the dune line but have been exposed due to heavy beach erosion over the decades.

**Mine Control room.** July 2018, Matthew Nash-Arnold © Qld Govt.

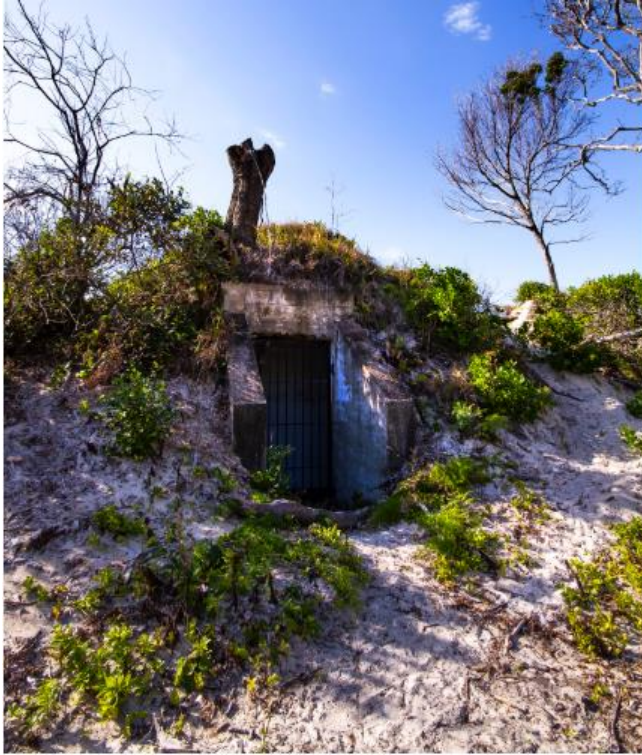
Photo 9: Mine Control Room entrance.

Photo, facing due east, of the Mine Control Room entrance, overgrown by vegetation.

Mine Control Room entrance. Photo July 2018, Matthew Nash-Arnold © Qld Govt.

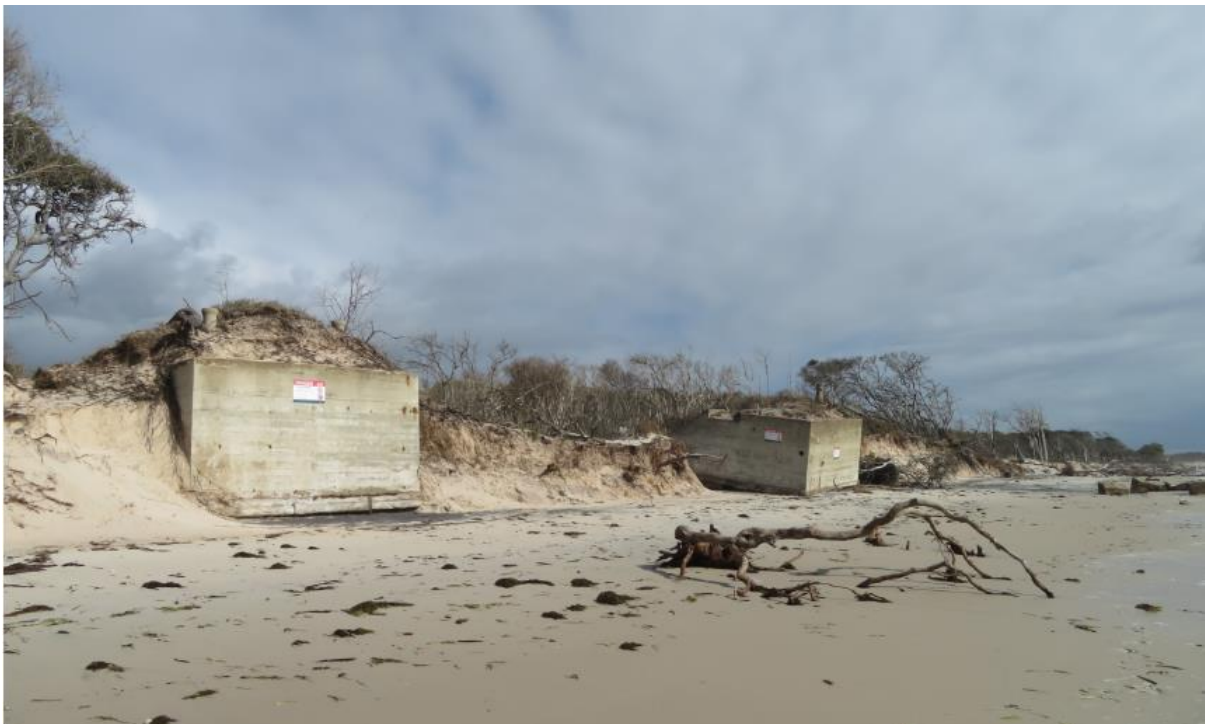
Photo 10: Mine Control Rooms.

In February 2019, large seas caused by Cyclone Oma hit Bribie Island producing significant beach erosion. This photo shows significant erosion to the sands around the northern mine control room which is no longer level.

Mine Control Rooms. Photo March 2019, Leanne Siebuhr © Qld Govt.

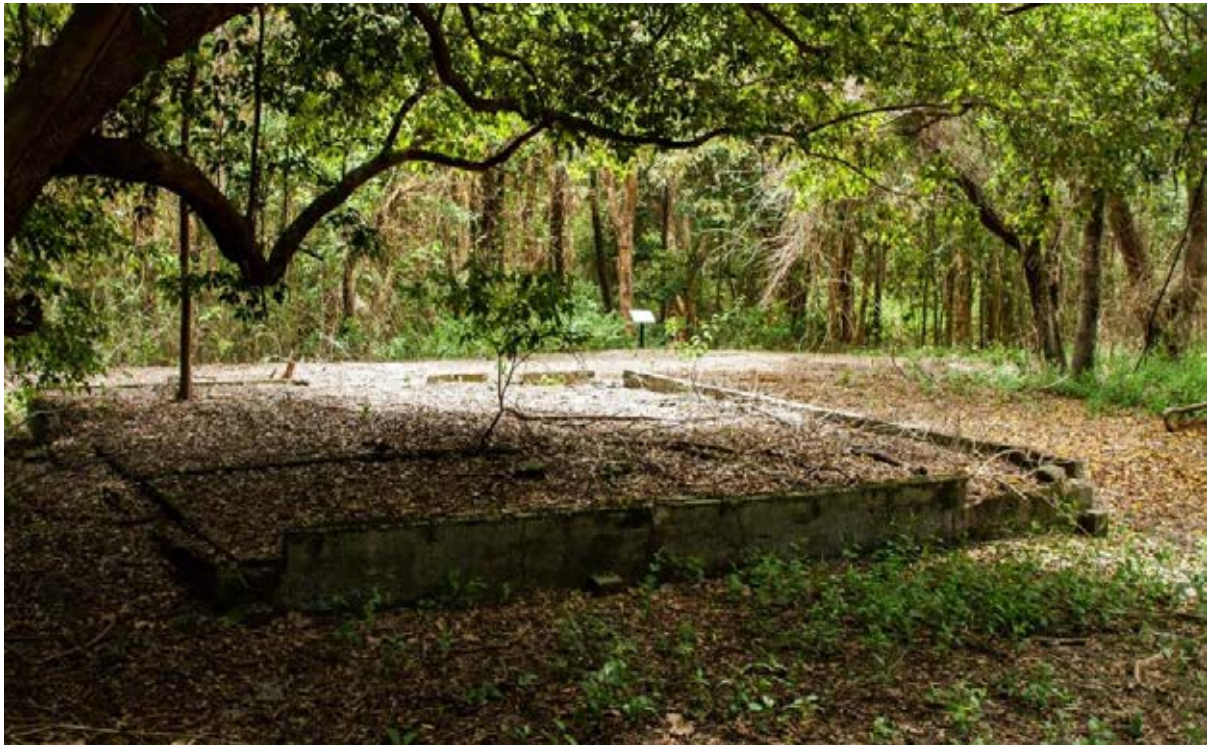
Photo 11: Officer's mess building footings.

Photo of the Officer's mess building taken from the southern end of the structure. The building was a split-level structure.

Officer's mess building footings. Photo taken November 2018, Matthew Nash-Arnold © Qld Govt.

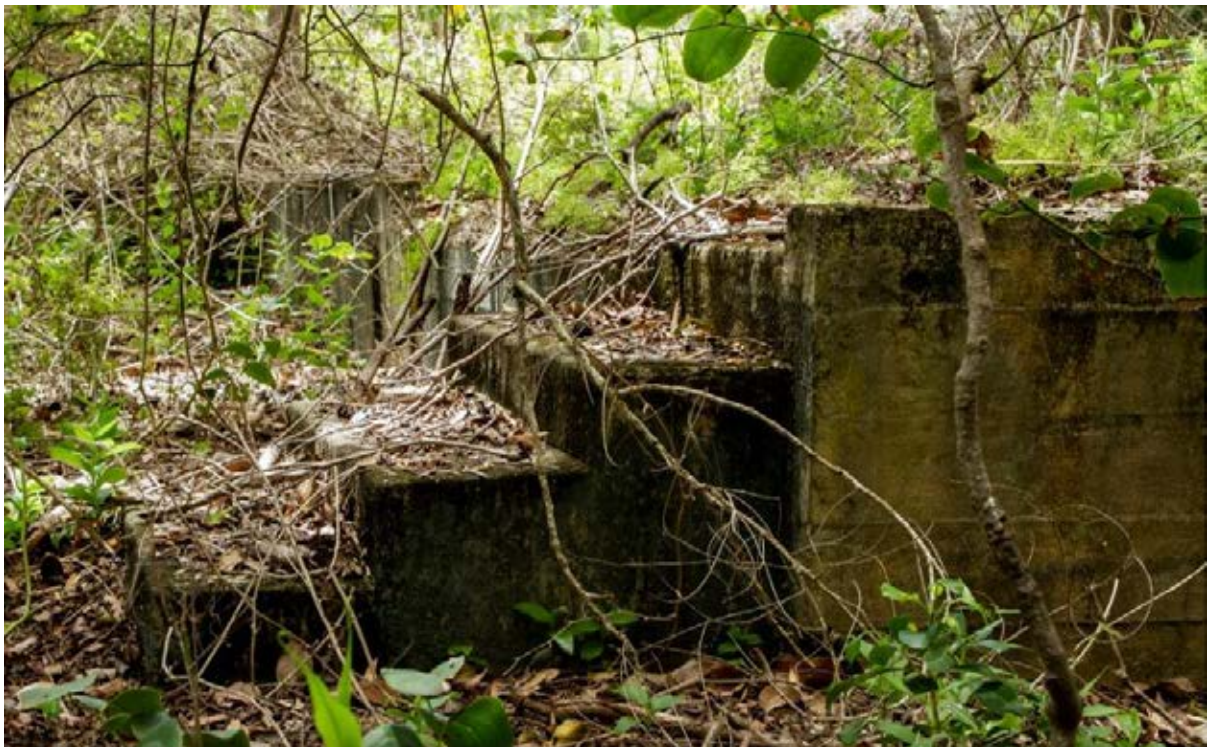
Photo 11: Stairs.

Remaining set of stairs to a raised building footing, possibly to the kitchen or one of the mess buildings.

Stair remains. Photo taken November 2018, Matthew Nash-Arnold © Qld Govt.

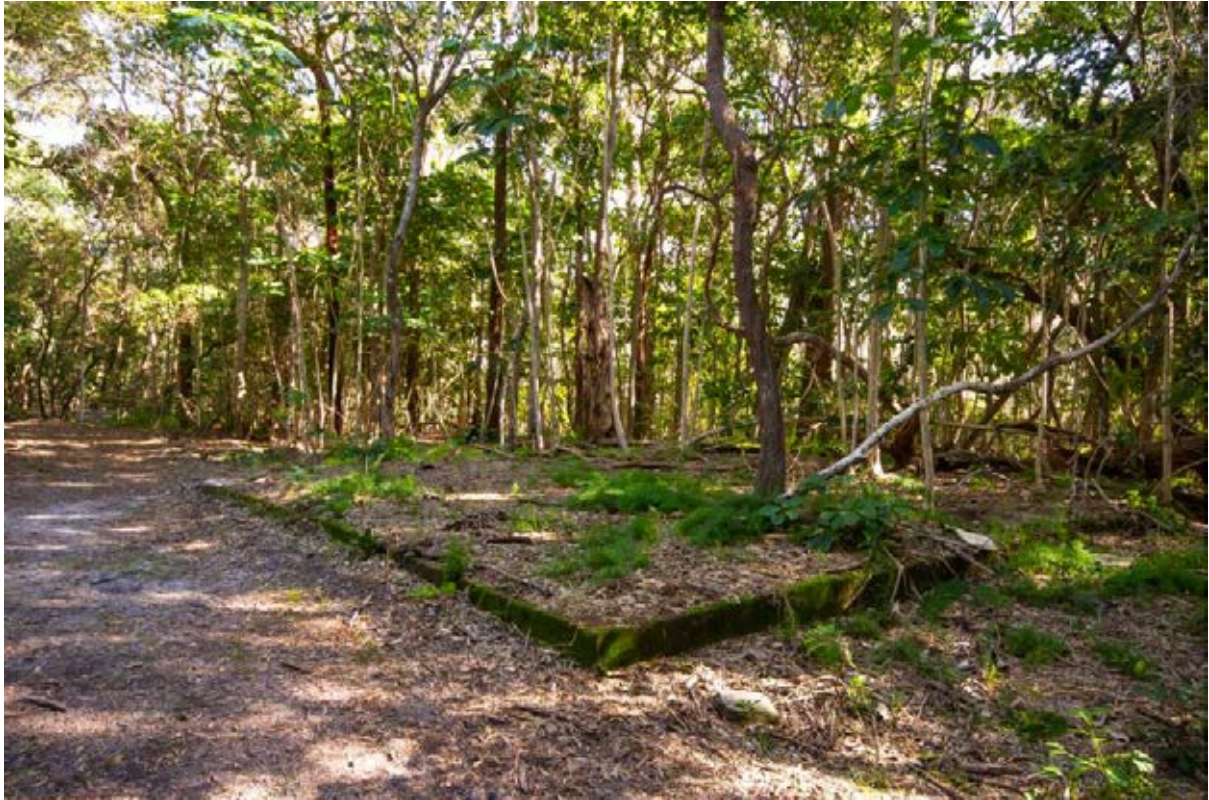
Photo 13: Sleeping quarters footings.

Sleeping quarters footings. July 2018, Matthew Nash-Arnold © Qld Govt.

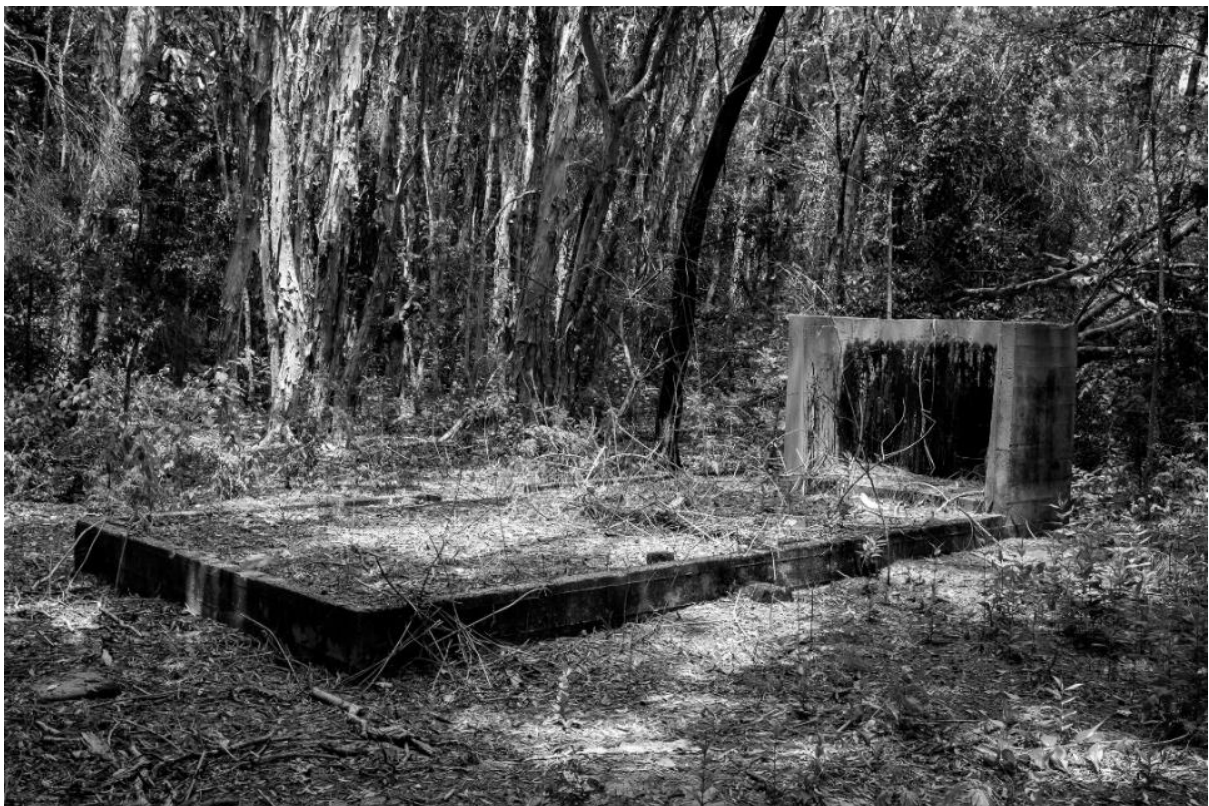
Photo 14: Officers' latrine and showers.

Officers' latrine and showers. Photo Matthew Nash-Arnold © Qld Govt

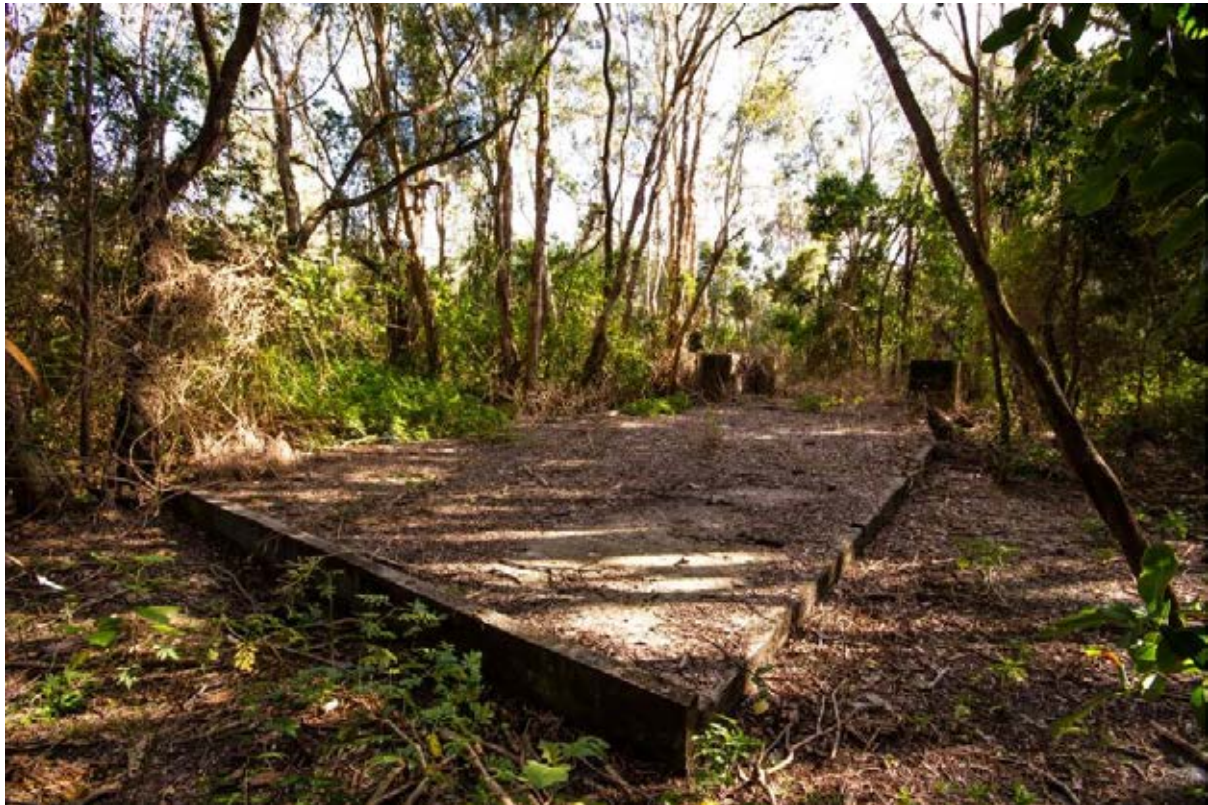
Photo 15: Men's latrine.

The men's latrine and shower block footings and slab, taken from the south east corner of the block.

Men's latrine footings. November 2018, Matthew Nash-Arnold © Qld Govt.

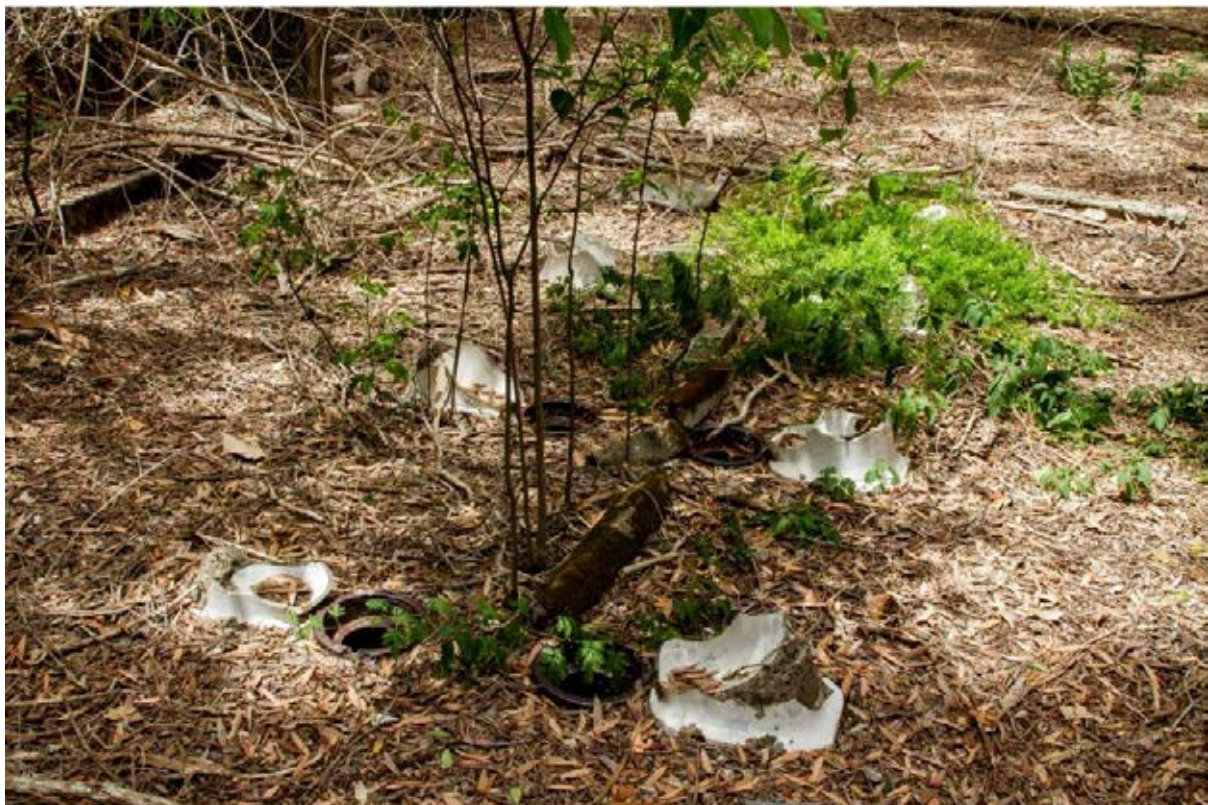
Photo 16: Remains of the men's latrine toilets.

Remains of the men's latrine toilets. November 2018, Matthew Nash-Arnold © Qld Govt.

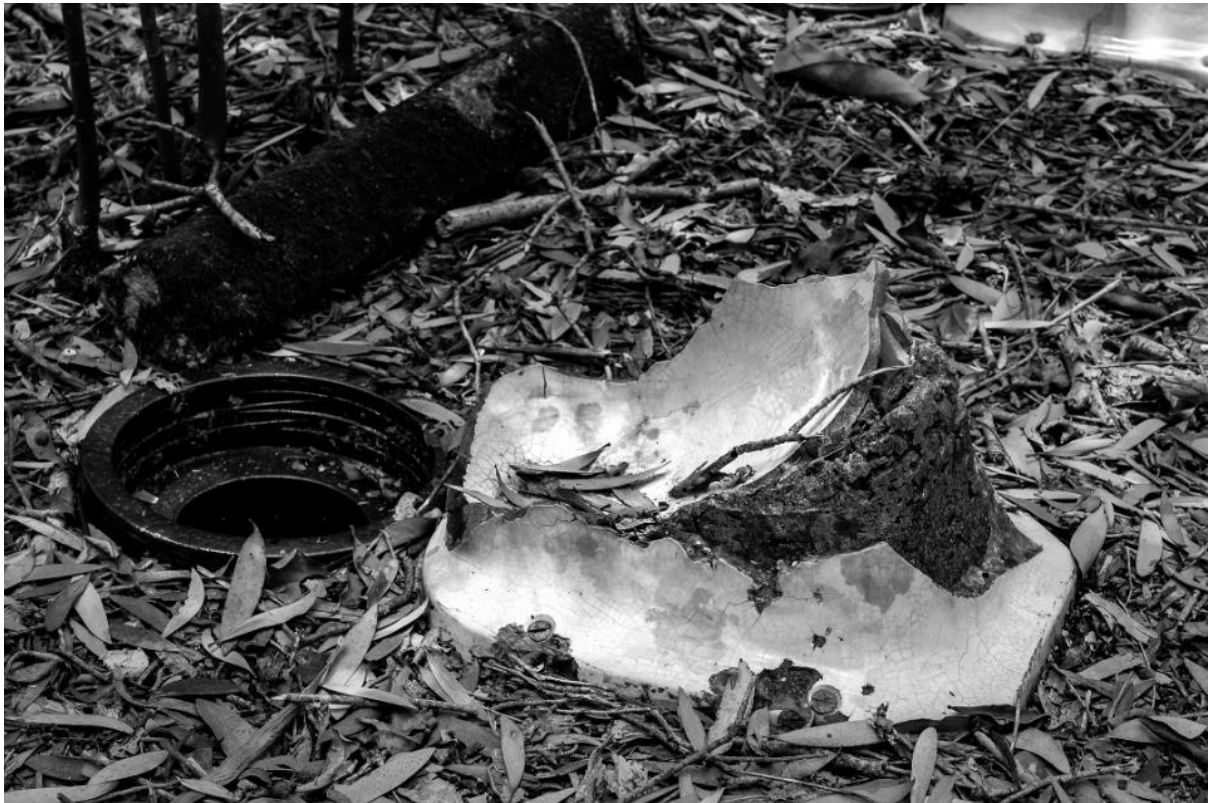
Photo 17: Men's toilet remains.

A close up of what remains of one of the toilets in the men's latrine.

Close-up of remains of toilet. November 2018, Matthew Nash-Arnold © Qld Govt.

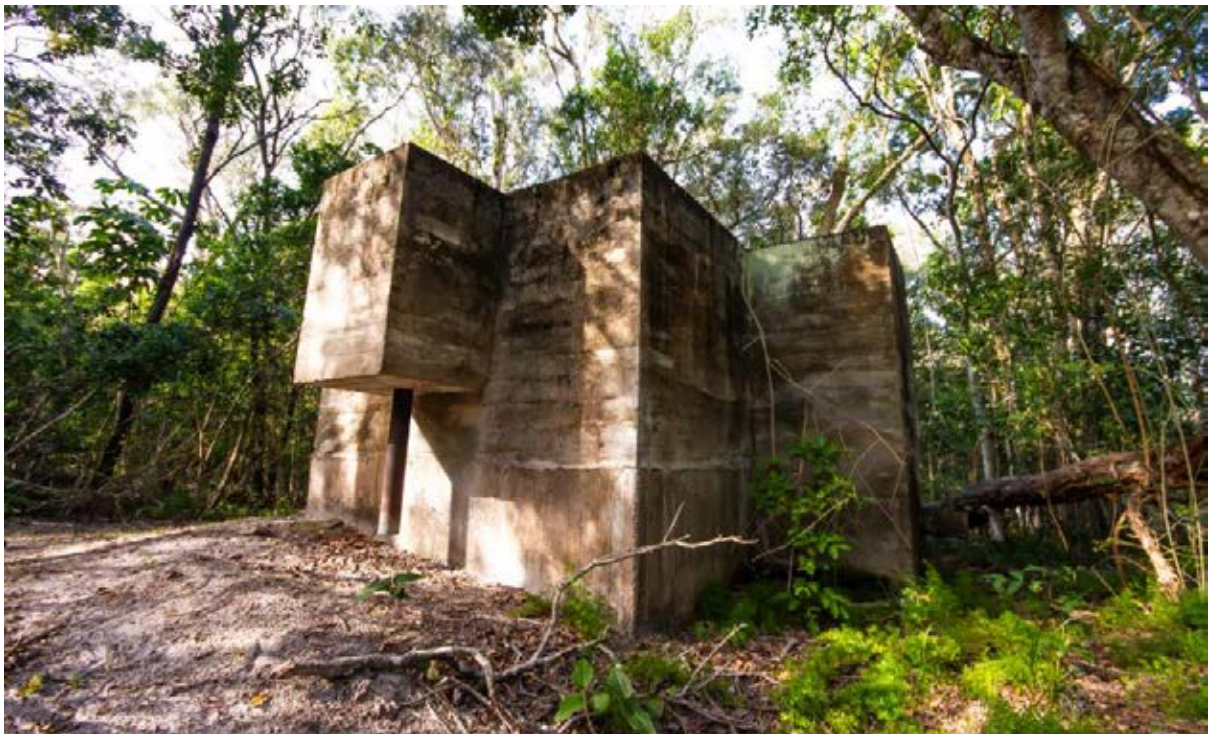
Photo 18: Septic tank.

Latrines facilities for the fort feed into this septic tank. Once treated the sewage was pumped via a pipeline to Pumicestone Passage, July 2018.

Septic tank. July 2018, Matthew Nash-Arnold © Qld Govt.

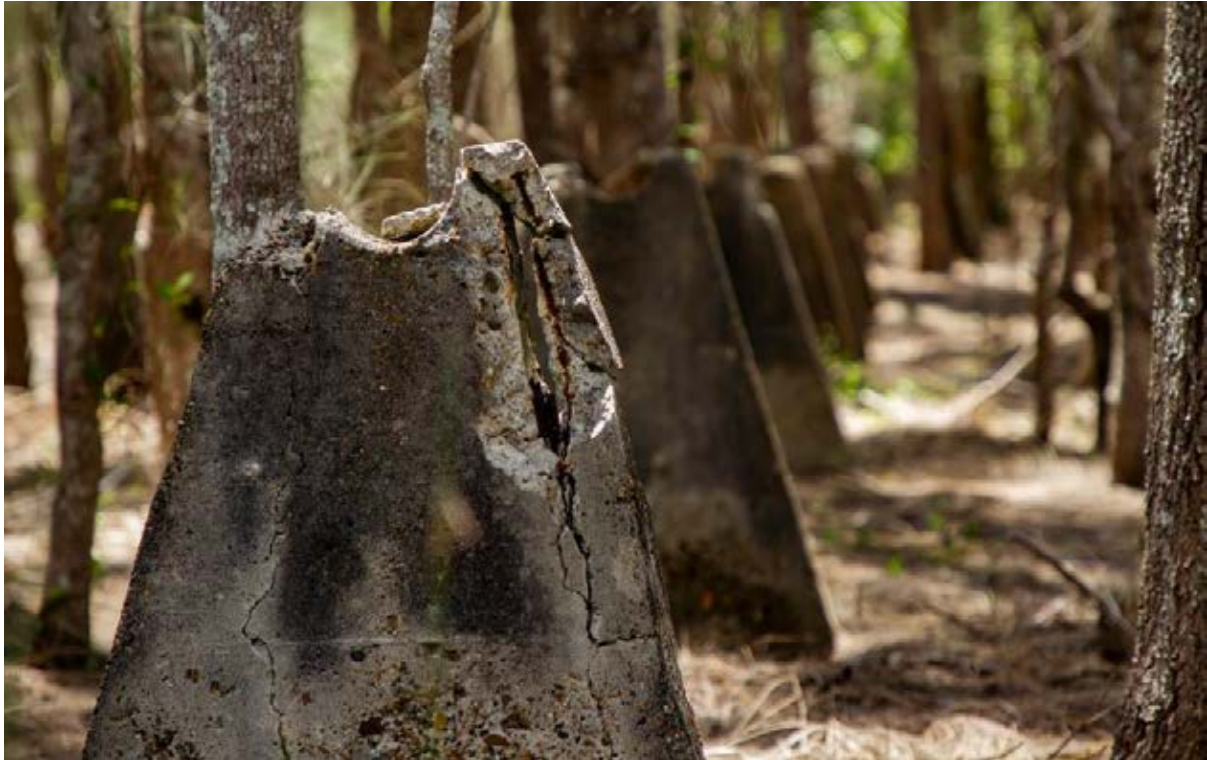
Photo 19: Septic line piers.

Once the sewage had been treated in the septic tank it was transported to Pumicestone Passage via a pipe line. The piers seen in this photo supported the pipeline. Photo taken looking due west towards Pumicestone Passage.

Septic line piers. November 2018, Matthew Nash-Arnold © Qld Govt.
