## Fort Bribie – defending Brisbane in WW11

Fort Bribie was built to defend the North West Channel into Moreton Bay during WW II. Now its remains are under attack from a different challenge: the persistent forces of coastal erosion.

Queensland National Park rangers are working to preserve Fort Bribie digitally through imagery, GIS mapping and 3D rendered modelling. We invite you to explore the fort when it was operational, view the changes over time, and appreciate the coastal processes that will eventually bring its demise.

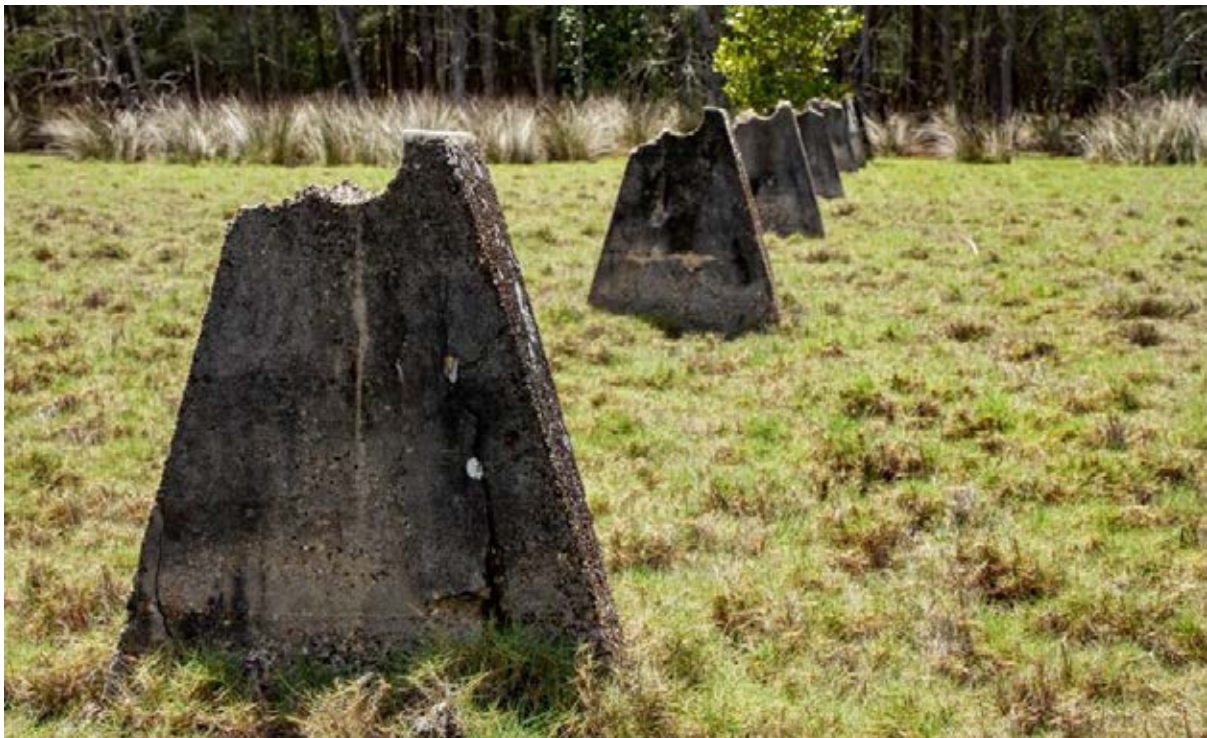
Photo 20: Septic line piers.

Photo taken looking east to the septic tank.

Septic line piers, looking east to the septic tank. November 2018, Matthew Nash-Arnold © Qld Govt

Once the sewage had been treated in the septic tank it was transported to Pumicestone Passage via a pipe line. The piers seen in this photo supported the pipeline. Photo taken looking due west towards Pumicestone Passage.

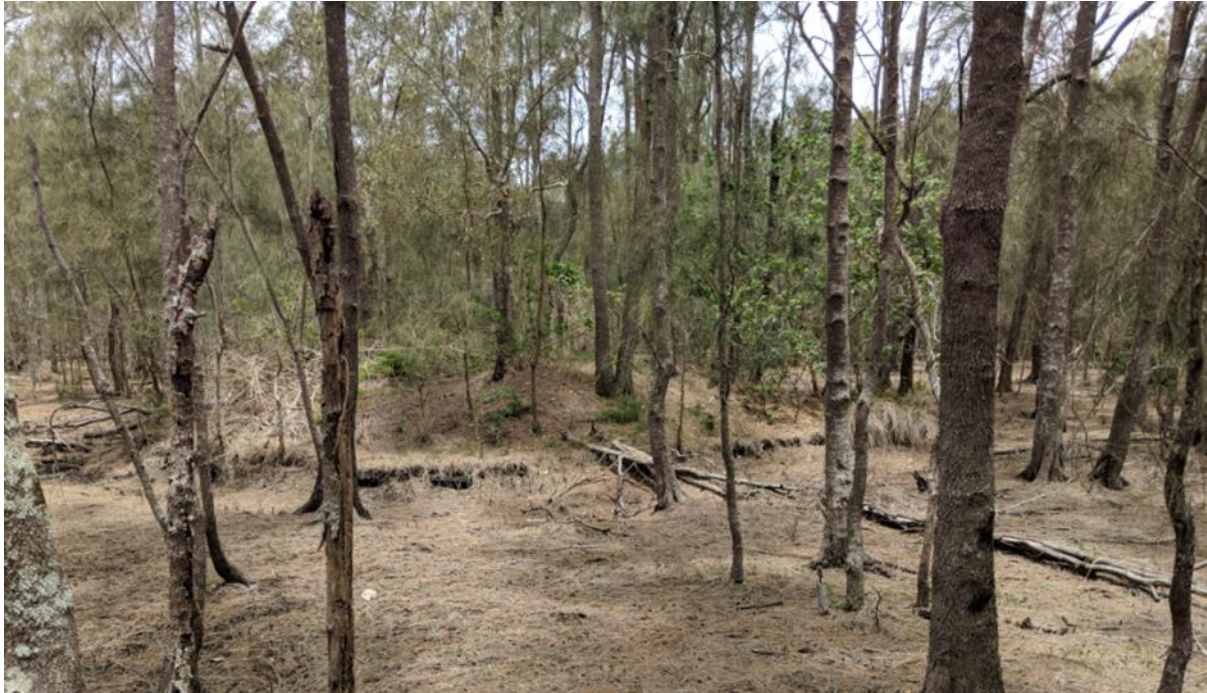
Photo 21: Machine gun position.

Approximately a dozen machine gun and mortar positions were established west of the fort to protect from invasion from Pumicestone Passage. This photo shows one of the raised sand mounds used as a defensive position.

**Machine gun position.** December 2018, Marcus Toyne © Qld Govt.

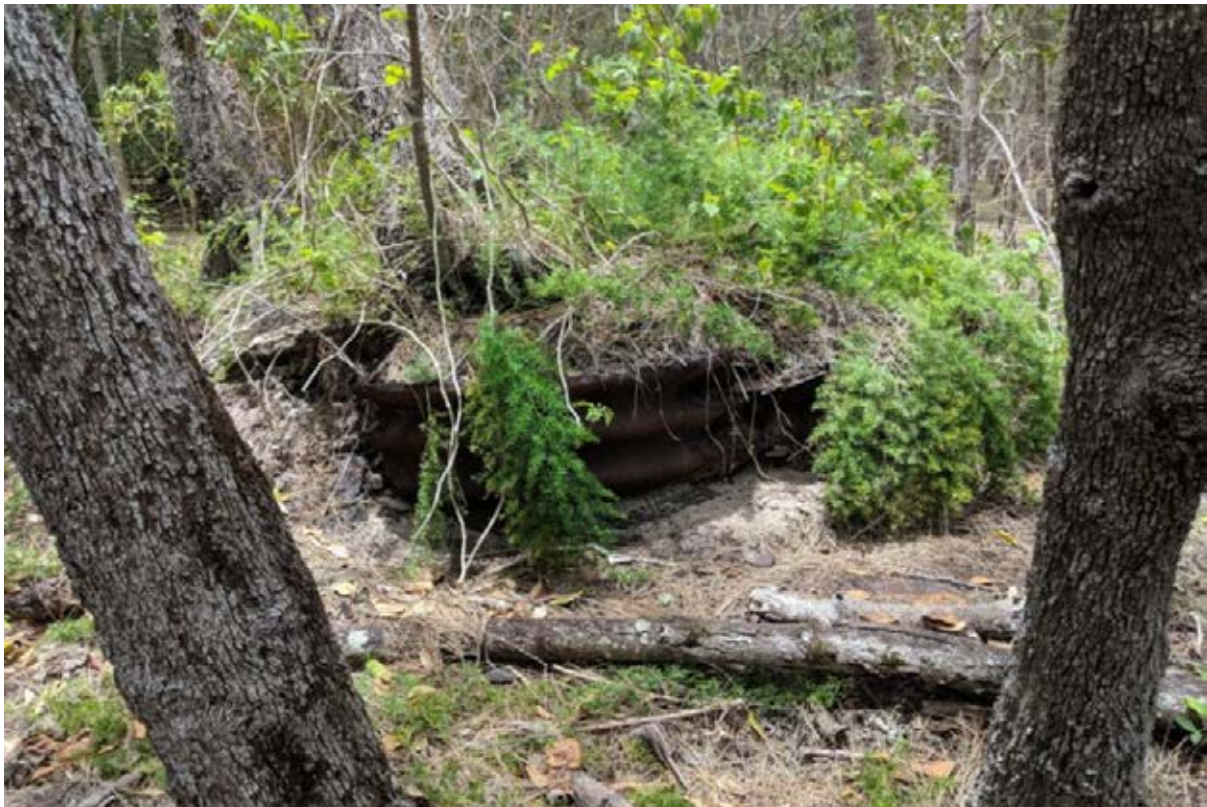
Photo 22: Mortar position.

Photo showing the remains of one of the mortar positions located to the west of the fort.

**Mortar position.** December 2018, Marcus Toyne © Qld Govt.

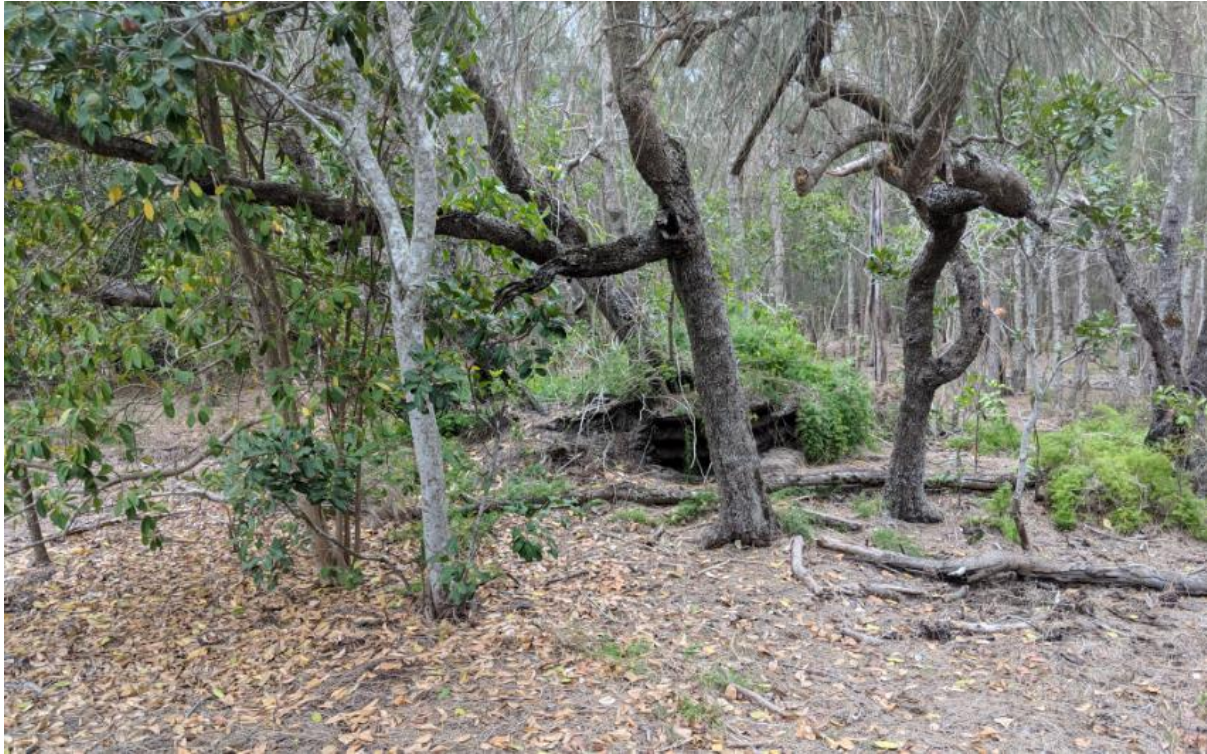
Photo 23: Mortar position.

Another mortar position located west of gun emplacement 2 (northern).

**Mortar position.** December 2018, Marcus Toyne © Qld Govt.

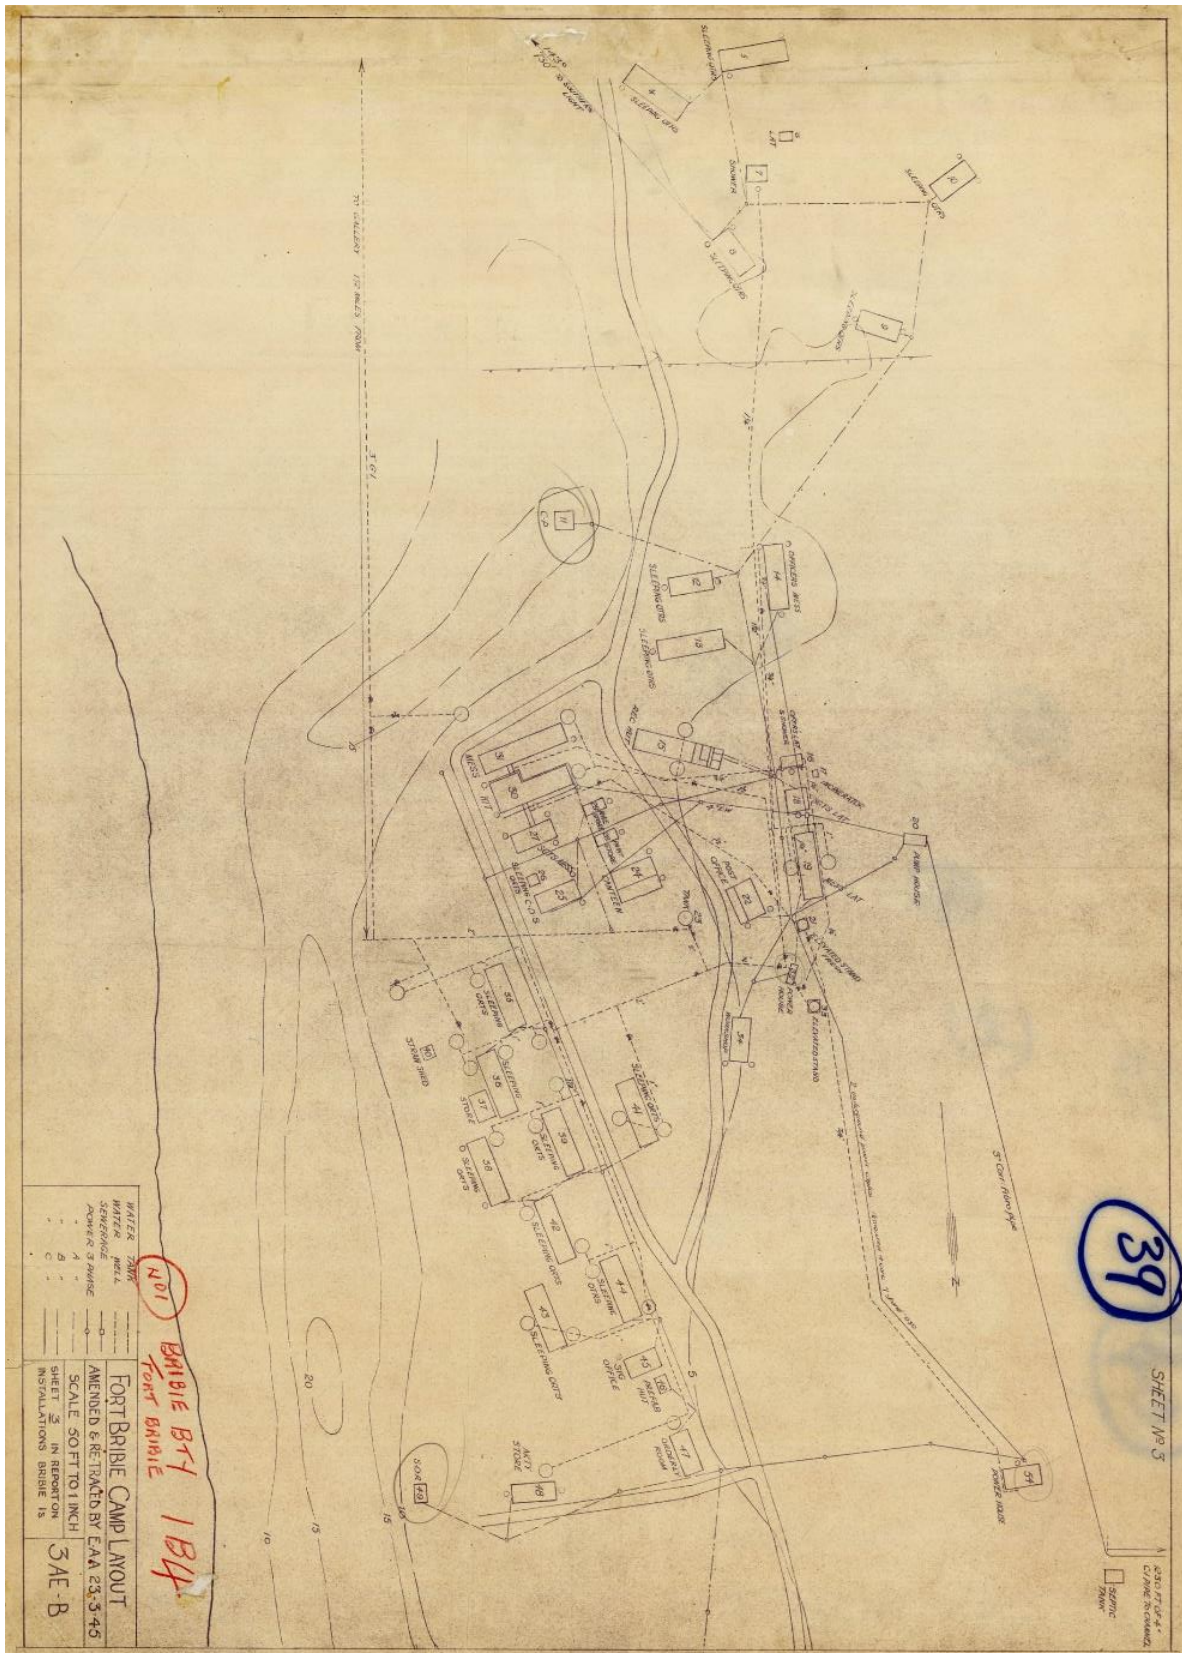
A map of the camp in 1945 when overlaid on an aerial photograph taken in 1961 can show that very little of the camp remained by 1961.

Map of Fort Bribie camp layout, 1945.

A 1945 map of Fort Bribie places the CP to the south of the camp (the southern searchlight is off the map), and a Signals Operations Room (SOR) is recorded east of the northernmost section of the camp, south of the southern (Number 1) gun. Reserve magazines are shown west of each gun emplacement. To the north of the northern (Number 2) gun the two Mine Control Huts formerly used by RAN Station 2 are marked as "Magazines", and the structure just to the northeast of these buildings is recorded as a BPR (Battery Plotting Room). Further to the north is a BOP, and beyond that the northern searchlight. An underground hospital, reported to have been built south of the officers' mess and sleeping quarters, is not marked on this map.

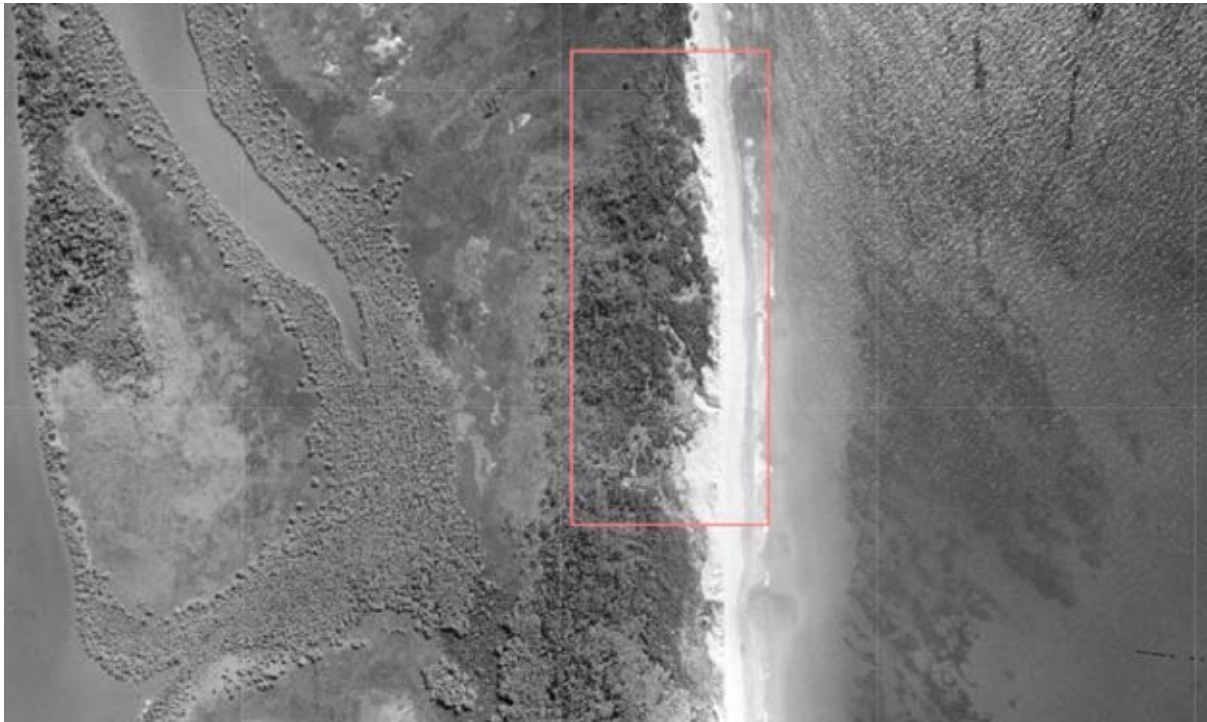
The background is part of the Noosa Heads - Bribie Island 1961 series (Film QAP1131 Frame 22 May 1961), of aerial photography at a scale of 1:12,500.

1961 aerial photograph of the Fort Bribie area highlighted with the red rectangle.

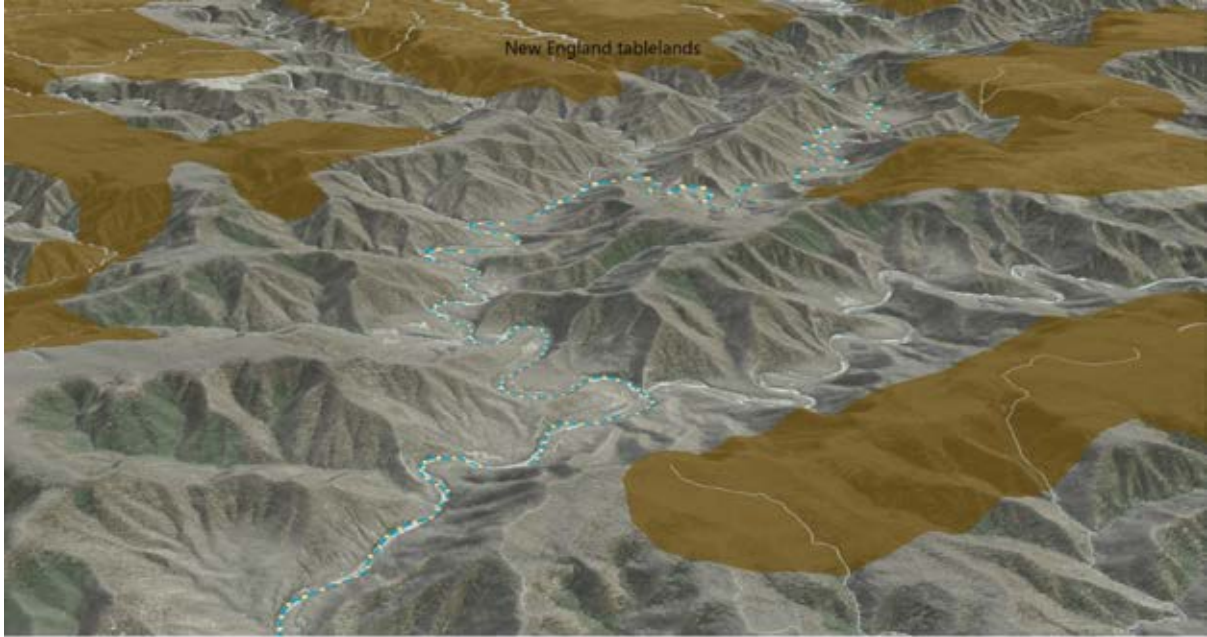
Diagram of New England tablelands topography. Diagram Marcus Toyne © Qld Govt.

Eroded from the granite rocks that dominate the region, the sand is carried down the Hastings, Macleay, Clarence, Brunswick and Tweed rivers to the New South Wales coast.

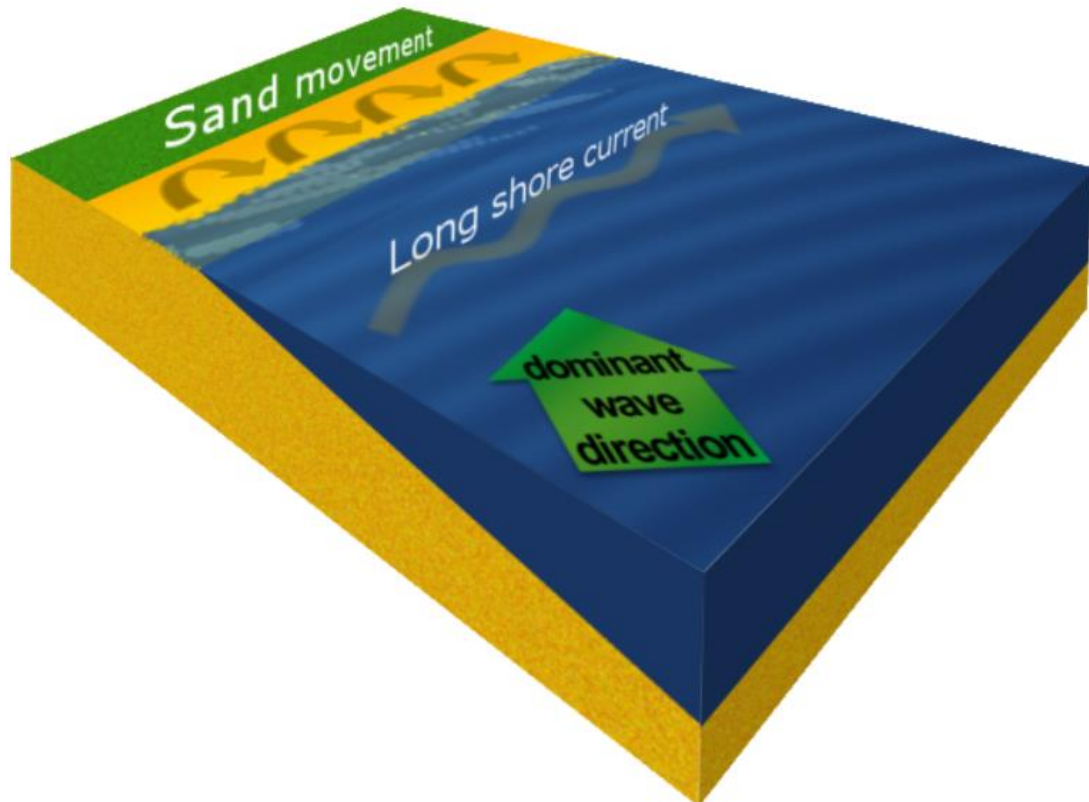
The process that moves sand along the coastline is called longshore drift. Surf zone currents, created by waves, and the predominant wave direction, influence the flow of sand. Under these conditions, waves break at an angle to the shoreline (forming oblique waves) and the sand is moved along the beach in the surf zone.

The process of longshore drift. Diagram Marcus Toyne © Qld Govt.

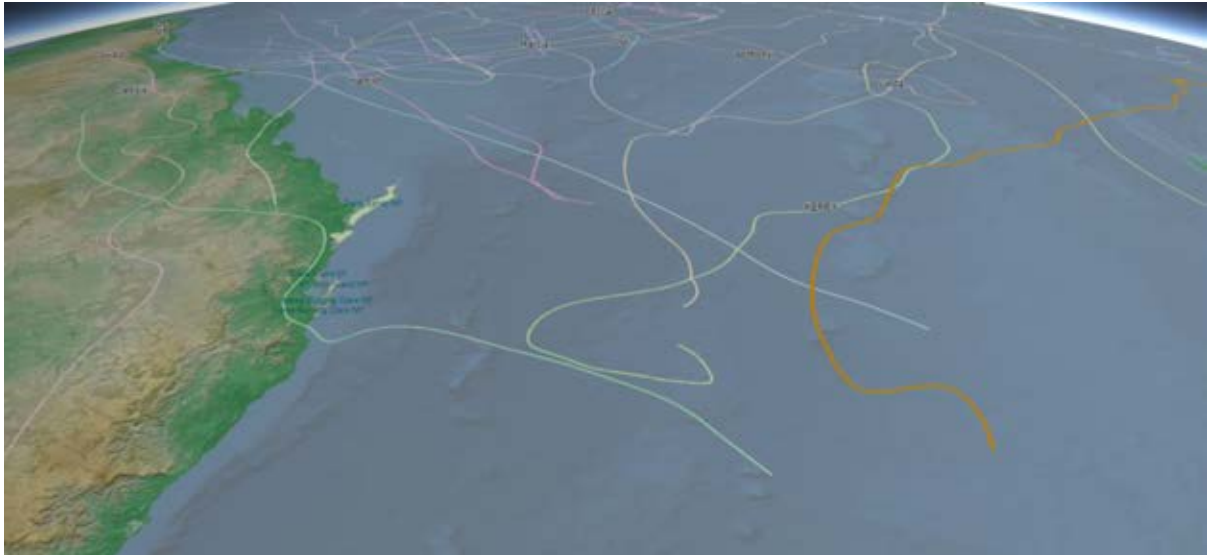
Cyclones, and the wild weather associated with them, impact our coasts significantly. The high winds, increased ocean water height, and wave action that accompany them cause coastal erosion and other changes to the shoreline. The magnitude and destructive power of the weather event, including wind speed, wind direction, wave action, and the status of the tide at the time of the event all influence the degree of impact.

Queensland cyclone pathways since 2000. Diagram Marcus Toyne © Qld Govt.

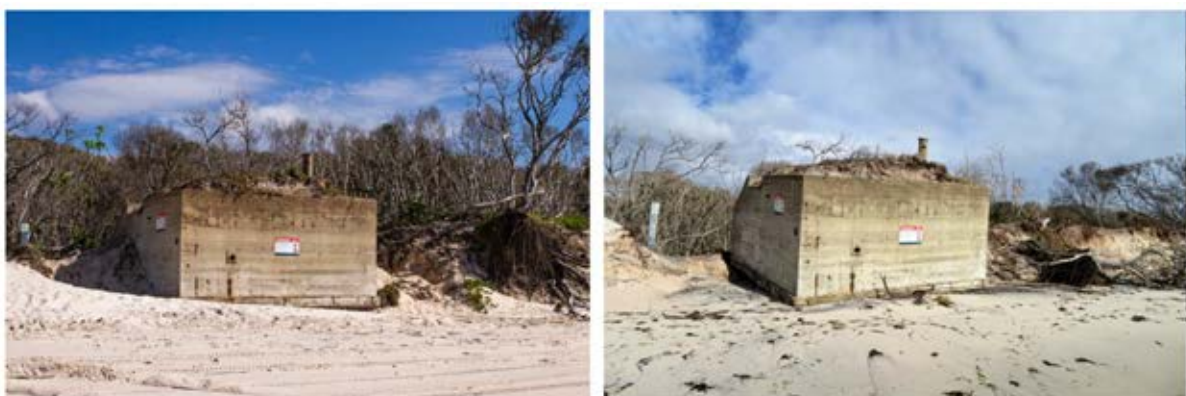
In February 2019 Cyclone Oma had a major impact on sections of Queensland's coast. Though it never made landfall, the high seas and turbulent weather battered the beaches of South East Queensland leaving major erosion in its wake. The photos below illustrate its impacts.

Fort Bribie mine huts. Left photo taken 21 July 2018 (Matthew Nash-Arnold © Qld Govt). Right photo taken on the 26 February 2019 (Brendan McLarty © Qld Govt).

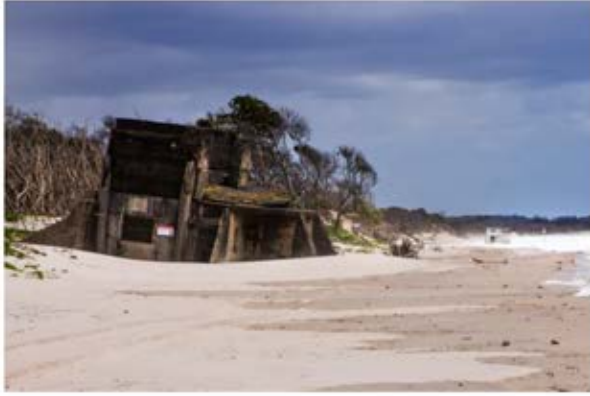
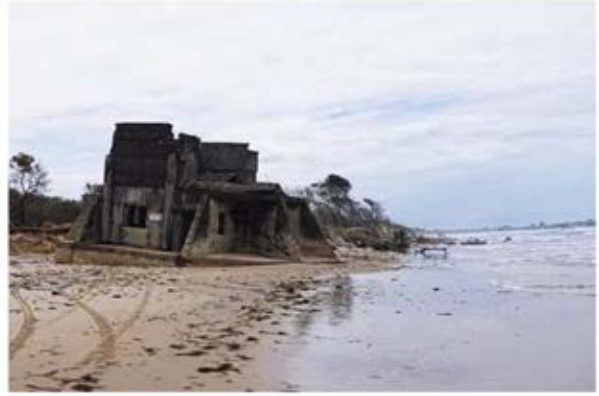
**Fort Bribie northern gun emplacement.** Left photo taken 21 July 2018 (Matthew Nash-Arnold © Qld Govt). Right photo taken on the 26 February 2019 (Brendan McLarty © Qld Govt).

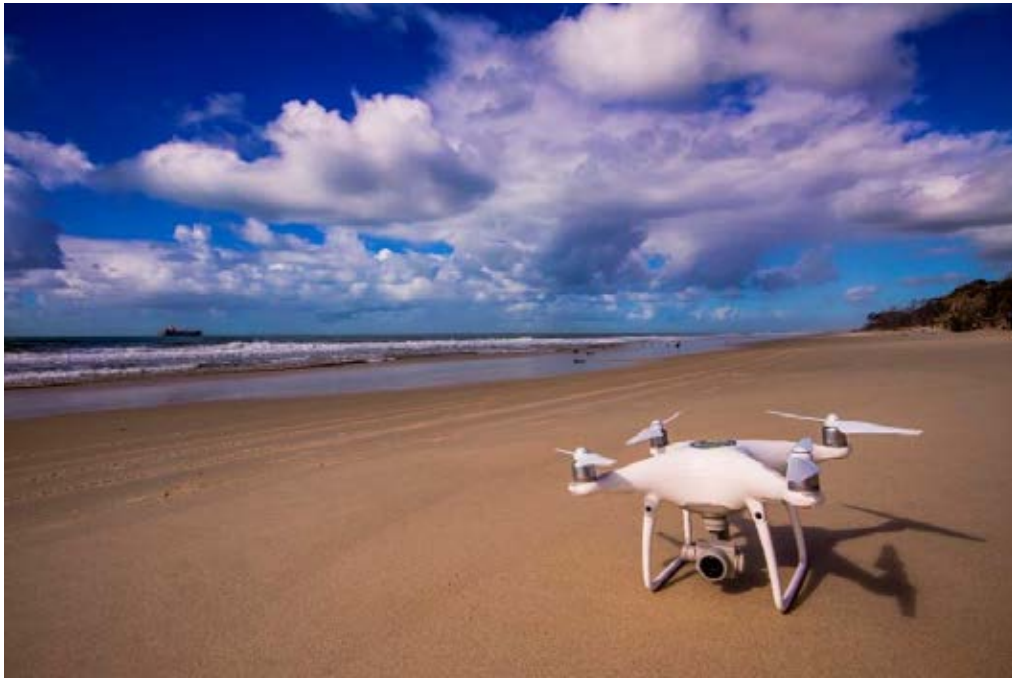
#### Image 4: Survey drone

DJI Phantom 4 drone used to perform aerial surveys of the historic fortification buildings. Photograph taken just north of the northern gun emplacement, looking south to Woorim.

**DJI Phantom 4 drone.** Photo Matthew Nash-Arnold © Qld Govt

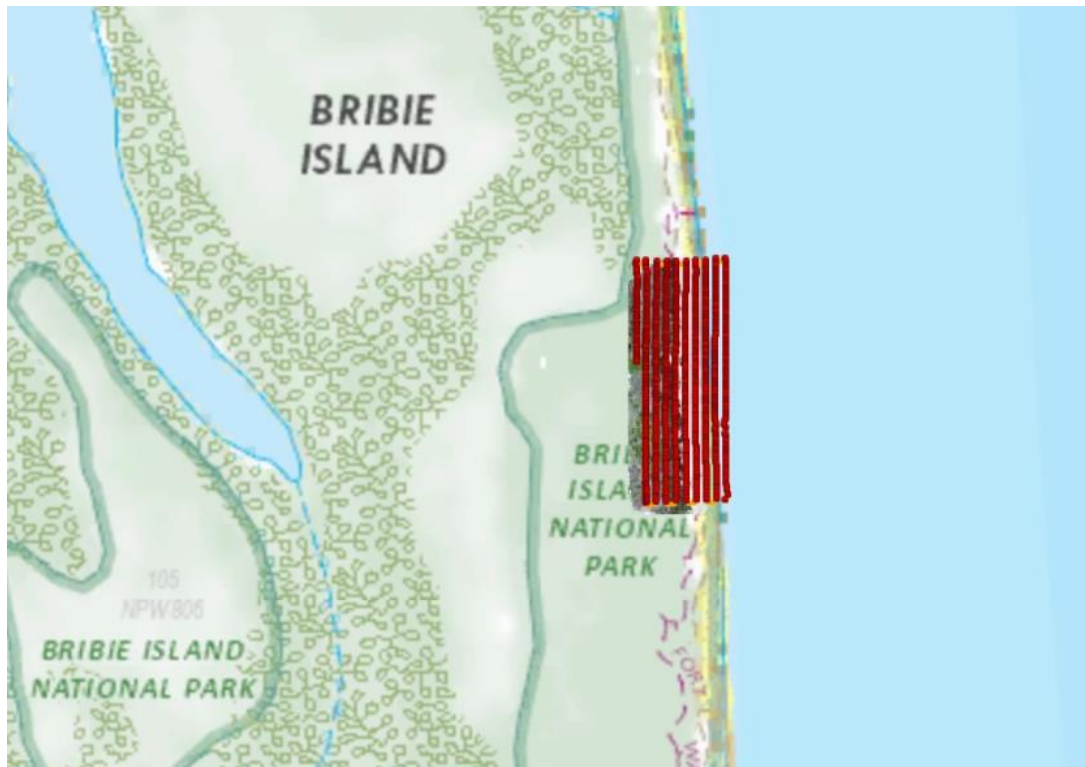
### Image 9: Drone flight path planning (overview)

Images are captured by the drone in a series of parallel runs (or lawnmower pattern - yellow lines) with photos taken at regular intervals along each run (red dots) evenly spaced to ensure sufficient overlap to build a composite image.

Drone flight pathways. Diagram Marcus Toyne © Qld Govt.

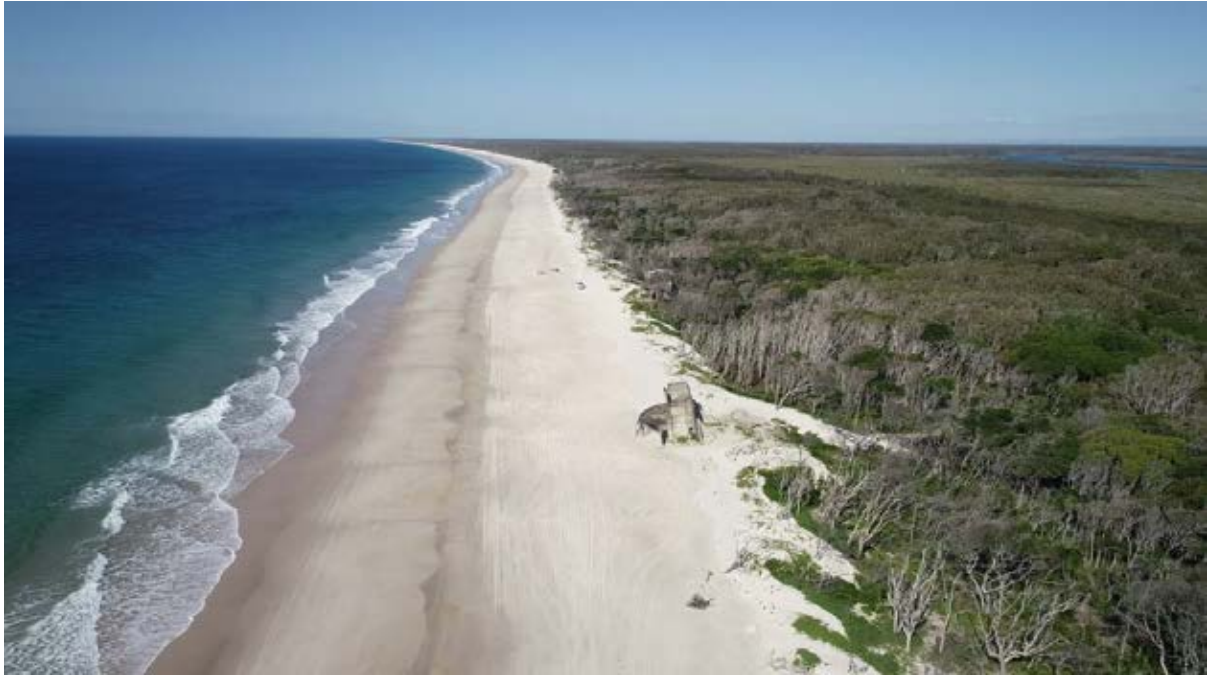
### Image 11: Drone photograph

High quality photograph looking south to Woorim captured from the drone during the site survey. The two gun emplacements can be clearly seen in the photograph, drone altitude is approximately 75 metres.

Drone's eye view. Photo Marcus Toyne © Qld Govt.

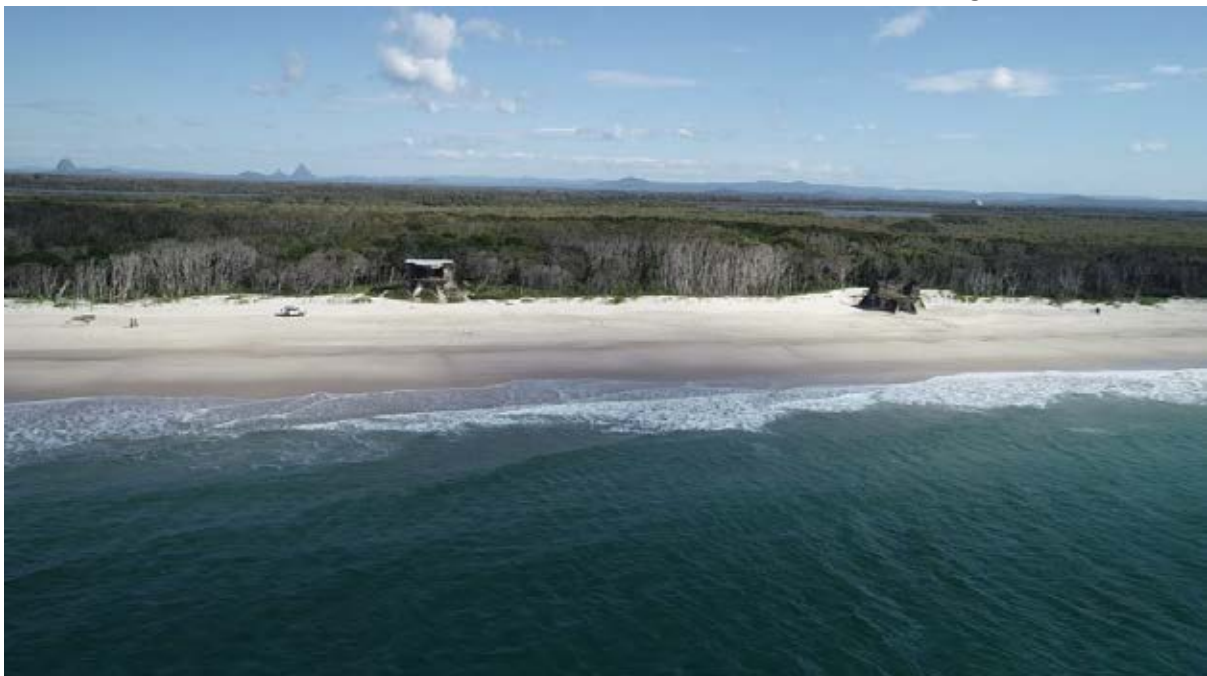
### Image 12: Drone photograph two

Photo of gun emplacements 1 and 2 taken during drone site survey at approximately 75 metres altitude. Orientation is west, the Glass House Mountains can be seen in the background.

Drone view looking west at beach, fort and Glasshouse Mountains. Photo Marcus Toyne © Qld Govt.

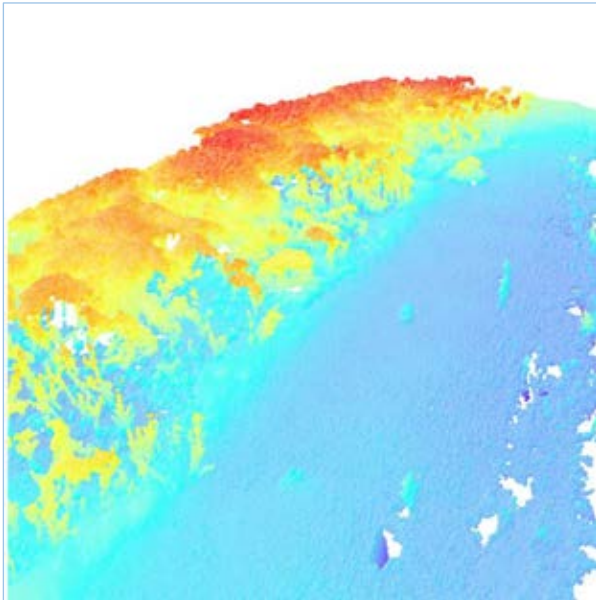
### Image 13: Point cloud diagram

This image shows the point cloud from the series of photos taken by the drone. When you take a series of overlapping aerial photos you can use the difference in them to calculate the height and position of an object. PhoDAR (Photographic Distance And Ranging) takes each point in the overlapping photos and calculates its position relative to all the other points. Using this technique we generated a 3D point cloud of the site.

Point cloud diagram. Marcus Toyne © Qld Govt

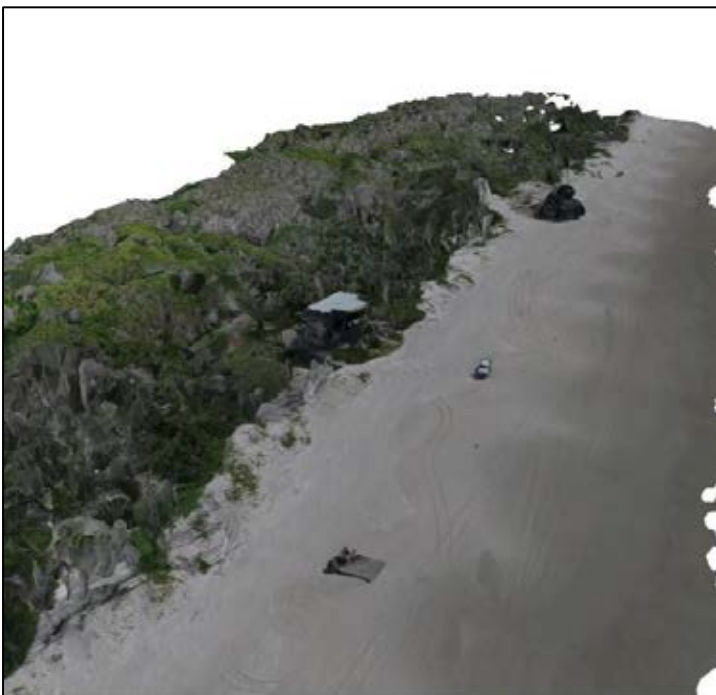
### Image 14: Textured mesh

This image shows the result of draping the stitched photos over the point cloud. The point cloud provided a location point for each bit of imagery to be positioned and creates a textured mesh. This in turn has the effect of generating a 3D model of the site. Gun emplacements 1 and 2 can be clearly seen in the 3D mesh model along with support vehicle.

Textured mesh model. Image Marcus Toyne © Qld Govt

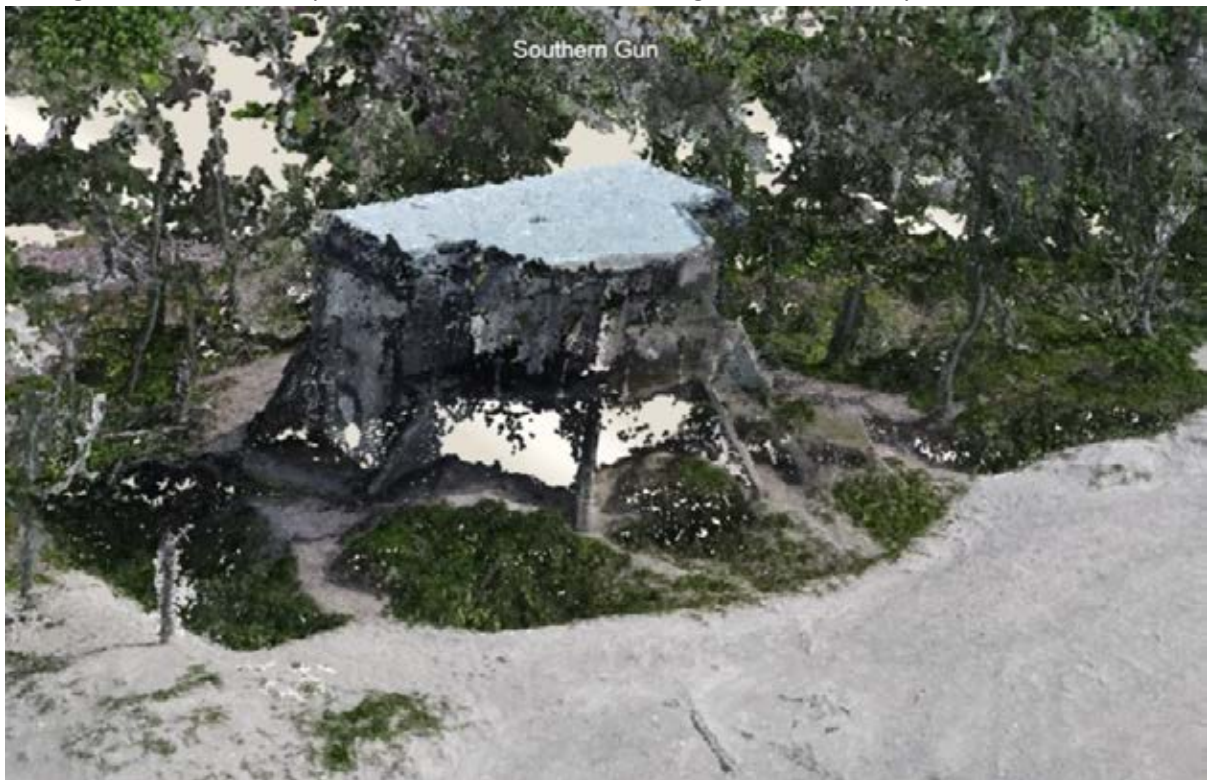
### Image 15: Point cloud image

This image is a rendered representation of the Number 1 (southern) gun emplacement which has been generated from the point cloud data collected during the drone surveys.

Textured mesh rendering of the Number 1 gun emplacement. Image Marcus Toyne © Qld Govt.

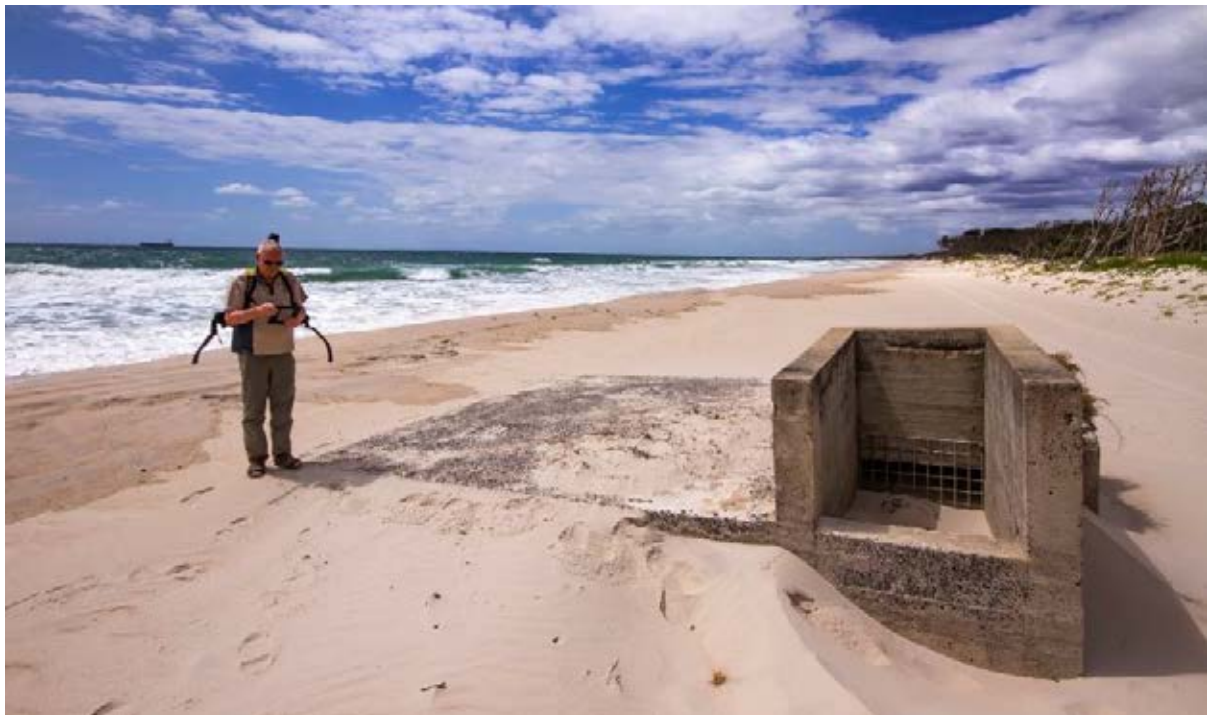
### Image 16: Locating fort structures

The team used a Trimble R1 GPS device to determine coordinates (to sub metre accuracy) for many of the fort structures. These coordinates were then used to geo-reference the 1945 mapping.

Recording the locations of fort structures. Photo Matthew Nash-Arnold © Qld Govt.

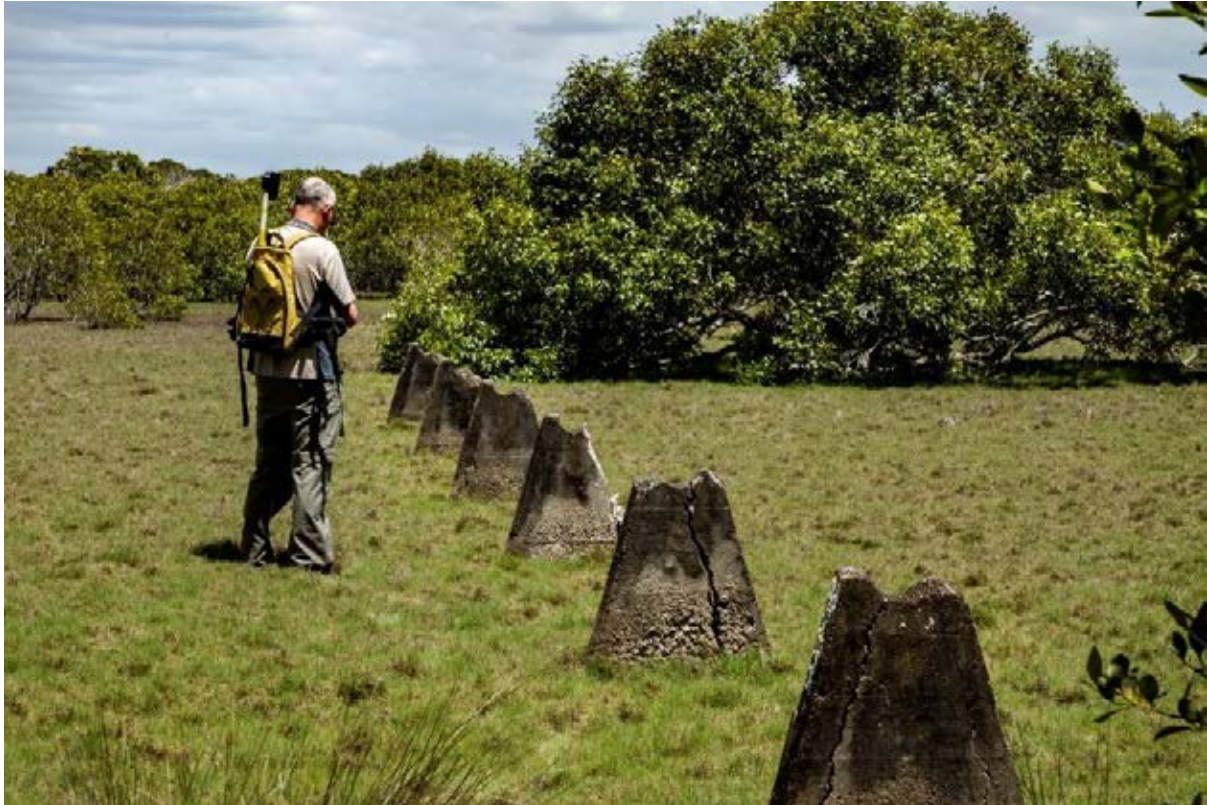
### Image 17: Pipeline Piers

Photo shows the pipe piercing structures that transferred waste liquids from the septic tank to Pumicestone Passage. Photograph orientation is west. Photo Matthew Nash-Arnold © Qld Govt.

Recording the pipeline pier locations. Photo Matthew Nash-Arnold © Qld Govt.

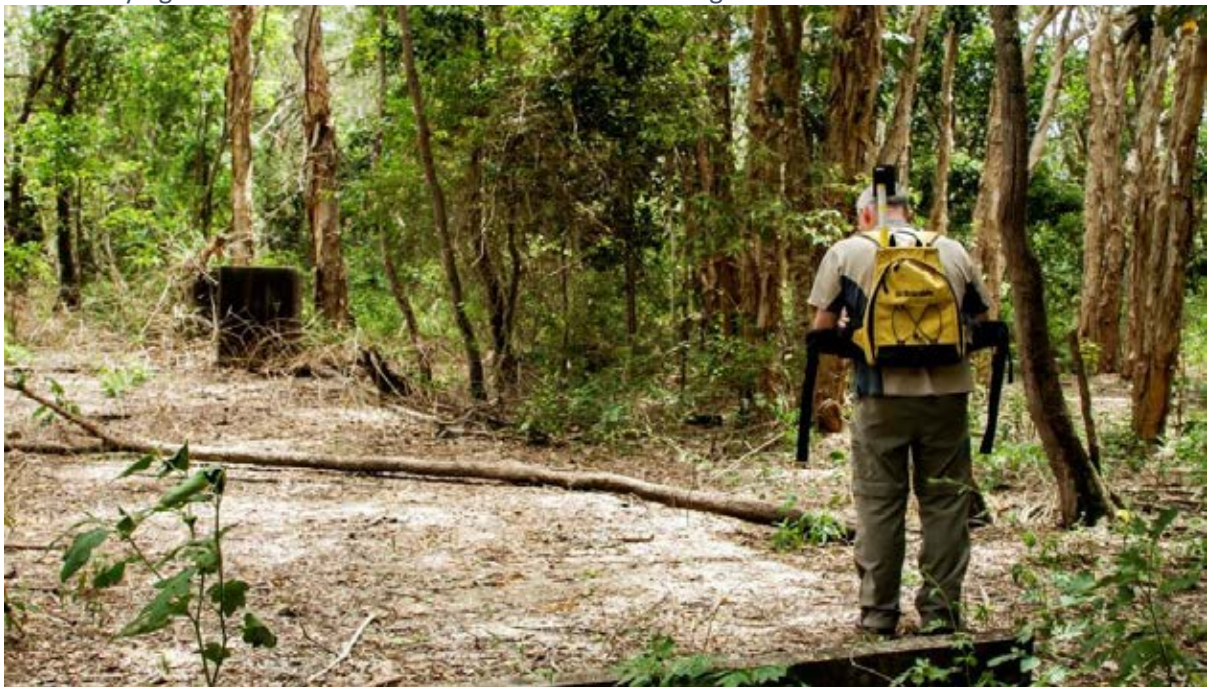
### Image 18: Structure footings survey

GPS surveying to determine coordinates of structure footings.

Recording location of building footings. Photo Matthew Nash-Arnold © Qld Govt.

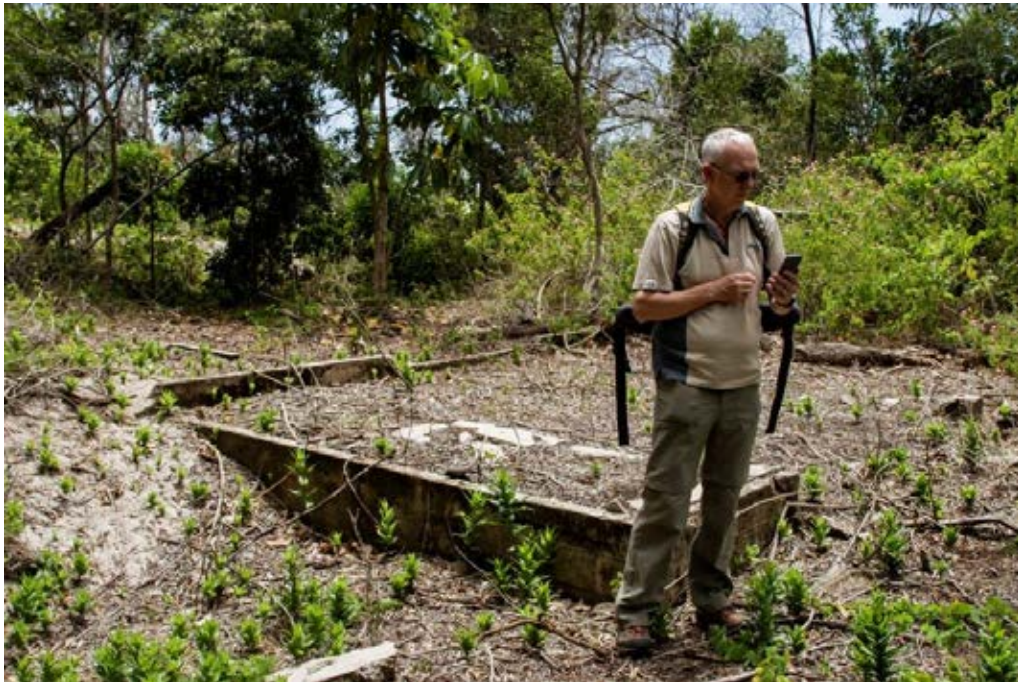
### Image 19: Structure footings survey continues

The coordination of numerous remaining structures was required to enable the successful geo-referencing of the historic 1945 mapping.

Recording structure footings. Photo Matthew Nash-Arnold © Qld Govt.
