# Risks associated with nearshore instability Inskip Point, Qld

Prepared for:  
Queensland Parks and Wildlife Service

Document Reference:  
B01006-IAE

Version:  
25 November 2015

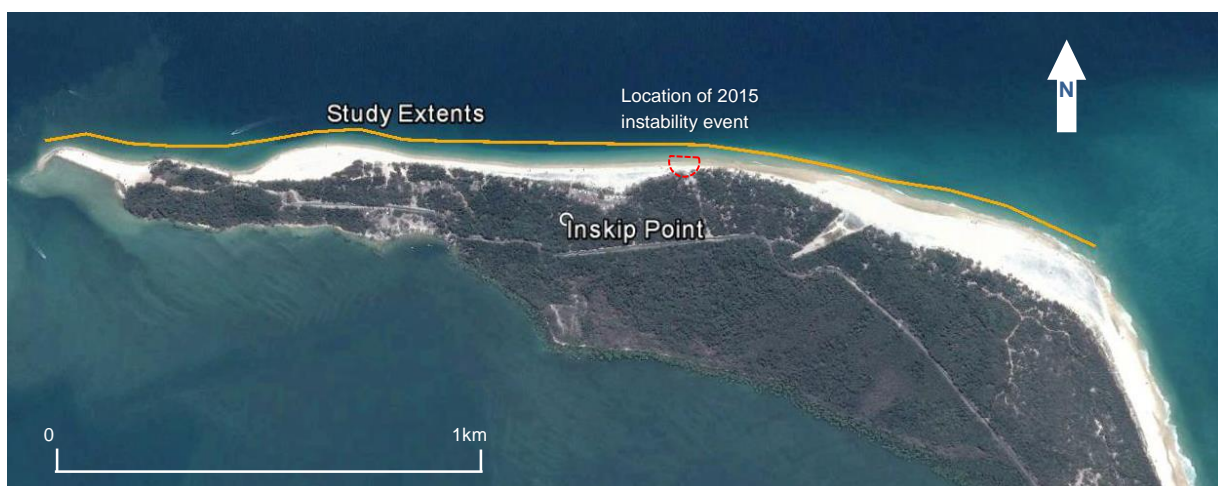
Figure 1.2 Extent of the study area – yellow line, relative to the zone of recent instability – red outline (Map Data: Google, CNES/Astrium 2015)

width from about 60 m to over 100 m over a distance of several hundred metres, and the slope down to the low water line flattens to about 1.5°. Figure 1.2 shows that to the west of the September 2015 instability event the tree line is irregular in shape, with broad scallops into the vegetation resulting in a widening of the beach. Drawing 1 is based on a topographic plot of the land based laser survey and bathymetry with a contour interval of 0.25m. The laser survey captures the trees as a series of closely spaced contours and so makes the tree line clear. This illustrates the varying widths of the beach, as defined by the position of the tree line, and shows the varying slope to different parts of the beach including the generally gentler grade down to the water-line east of the September 2015 instability event.
